WCC Marine Assets Structural Condition Assessment 2017

Prepared for Wellington City Council

Prepared by Beca Limited

29 March 2018

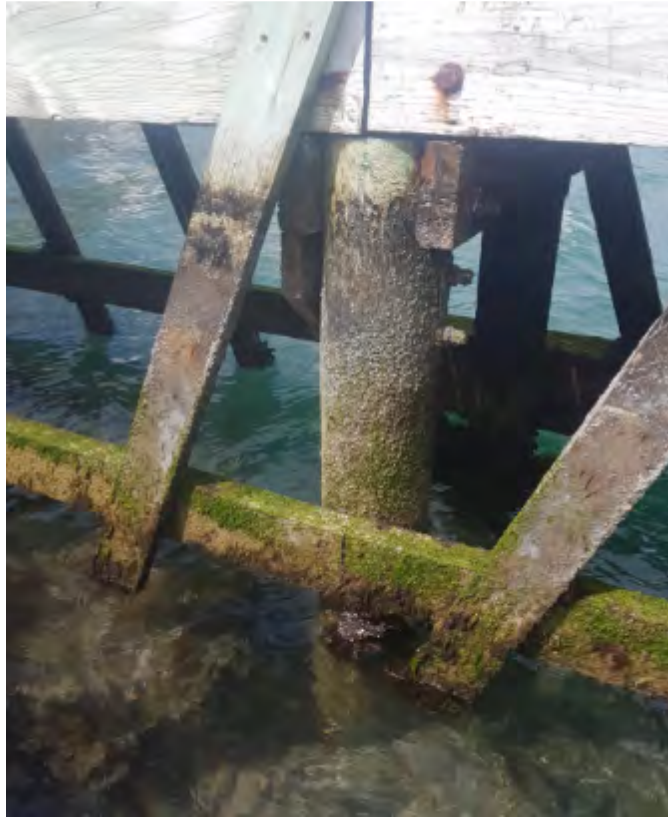
The piles were visually inspected both above and below water. Refer to Appendix A for details of the underwater visual assessment and Table 2-2 for a summary of the pile conditions. The piles were found to be in a reasonable condition both above and below water without the need for immediate maintenance actions. Refer to Figure 2-3 for a typical pile example.

Figure 2-3. Greta Point Wharf - Typical Condition of Piles

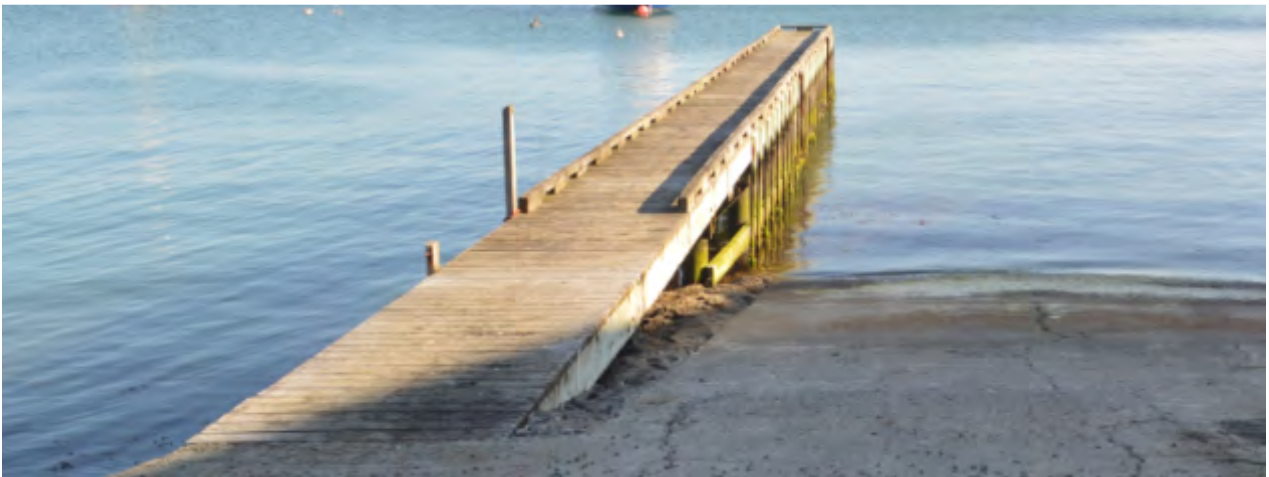
All timber decking was found to be in a good condition, refer to Figure 2-5, without the need for immediate maintenance actions.

Figure 2-5. Greta point wharf – Decking

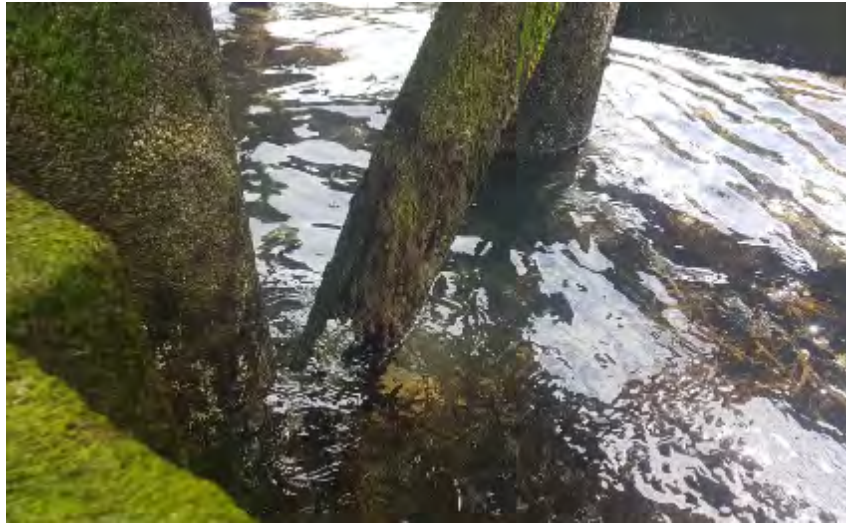
The horizontal and diagonal bracing was, in several instances, in a poor or very poor condition as shown in Figure 2-6. With significant rot and splitting having occurred causing significant cross-sectional losses. In these cases, replacement of timber bracing will be required within the next 12 months.

Figure 2-6. Greta Point Wharf – Deteriorated Pile Bracing

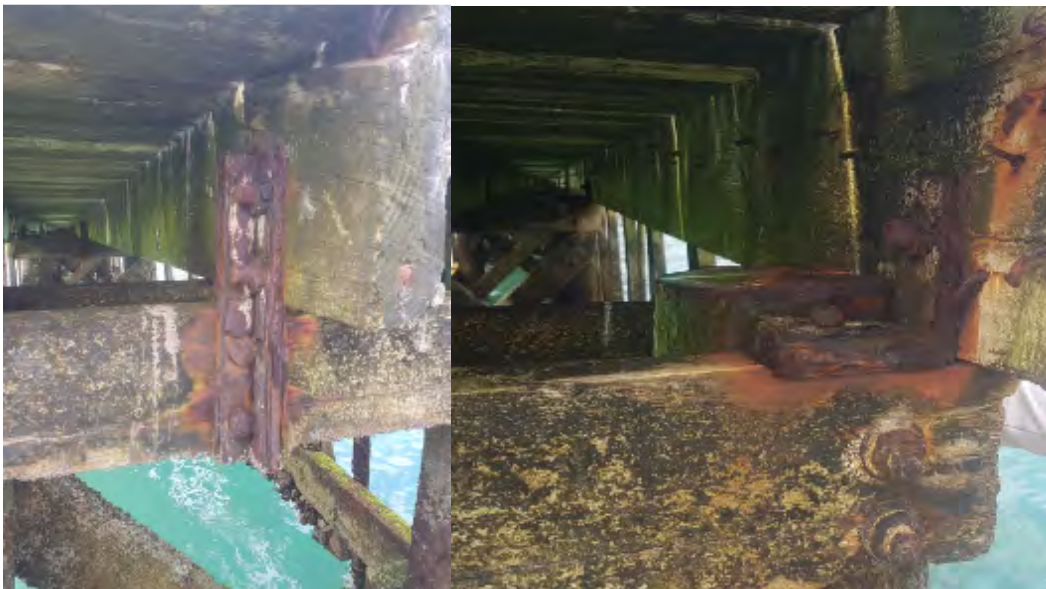
Figure 2-7 shows the bolted steel connections comprising bolts with nuts and washers, and steel brackets being subject to significant corrosion with the onset of delamination of the bracket plates. It is recommended that in the mid to longer-term (within 24 months) the steel connections are replaced before the condition of the connections deteriorates such that the structural integrity of the wharf is compromised.

Figure 2-7. Greta Point Wharf – Advanced Corrosion of Bolted Connections

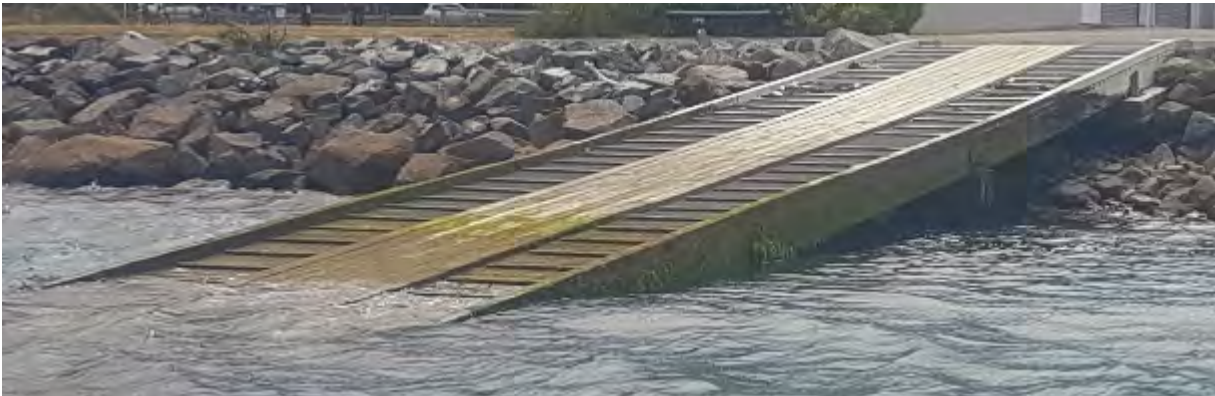
Both the joists and decking appeared to be in a reasonable condition with the typical onset of sea weed coverage and marine growth within the tidal zone. Refer Figure 3-3 below.

Figure 3-3. Cog Park Boat Ramp – Decking and Joist in Good Condition

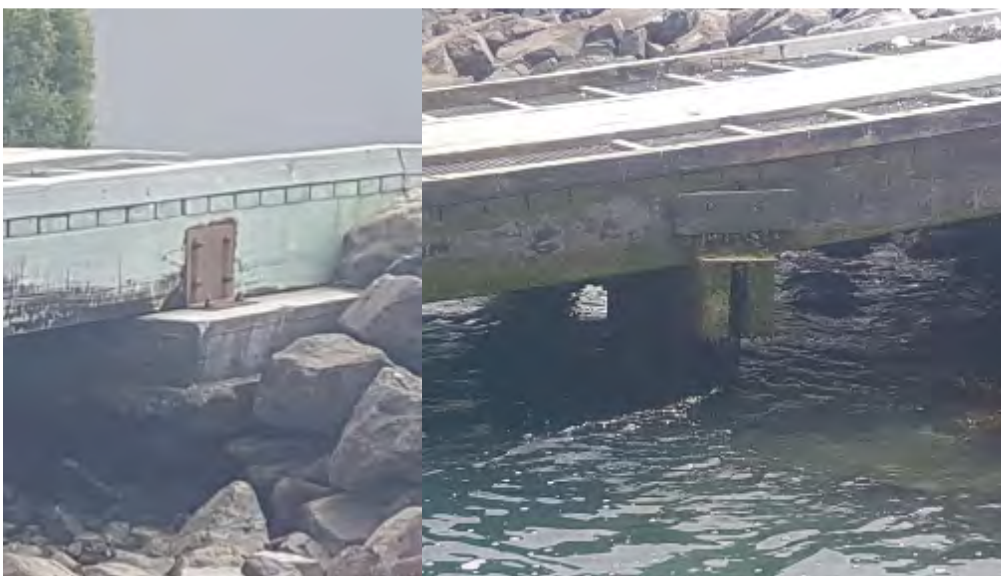
With the boat ramp being constructed in 2007, the bolted connections that could be visually assessed appeared to be in a reasonable condition with only the onset of surface rust. Refer to Figure 3-4. Therefore no further maintenance actions are suggested.

Figure 3-4. Cog Park Boat Ramp, Bolted Connections

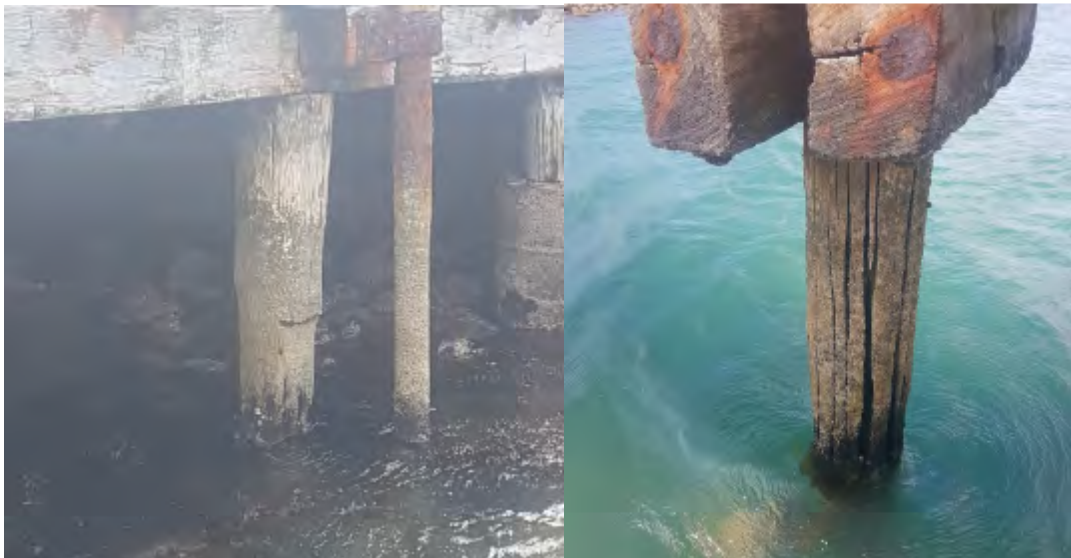
The piles were inspected visually both above and below water. Refer to Appendix A for details of the underwater visual inspection and Table 4-2 for a summary of the pile conditions. Above water, most piles were assessed in either a poor or very poor condition which was further confirmed by findings of the underwater inspection. In some instances timber piles have lost most or even the complete cross section which in some instance could only be observed under water, thus not visible from above water level. Refer to Figure 4-3 for typical piles.

Figure 4-3. Cog Park Jetty, Piles Cross Section Loss and Splitting

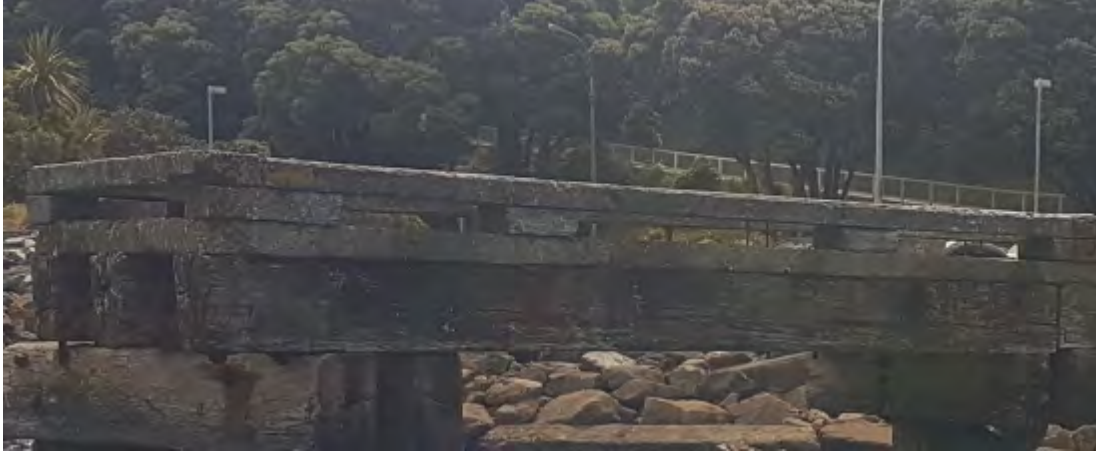
The joists showed a moderate extent of rot and splitting, in particular at the ends as illustrated in Figure 4-4 and Figure 4-5.

Figure 4-4. Cog Park Jetty – Representative View of All Joist

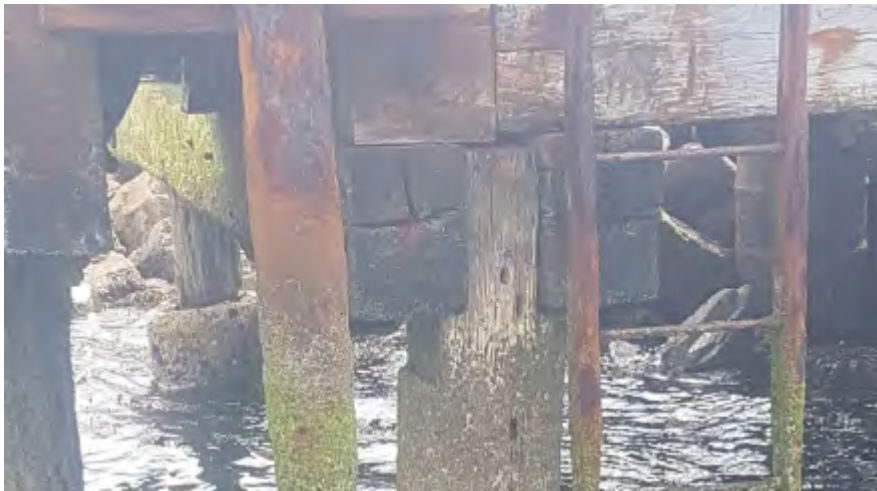
Figure 4-5. Cog Park Jetty – Observed Splitting of Ends of Bearers

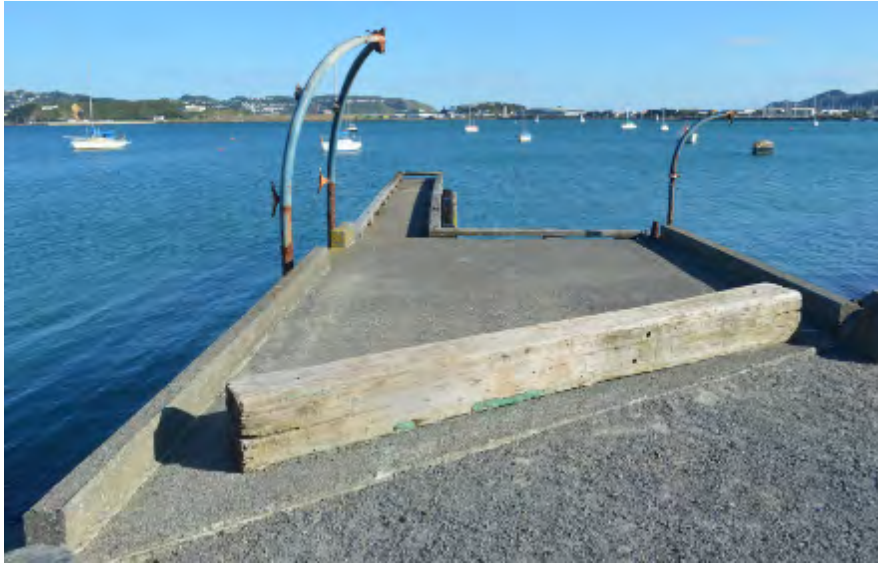
The concrete deck was considered to be in a reasonable condition, as illustrated in Figure 4-6. The sacrificial soffit steel formwork was severely corroded, see Figure 4-7, however without any noticeable consequence to the performance of the deck, which showed no signs of distress such as cracking.

Figure 4-6. Cog Park Jetty - Top View on Concrete Deck

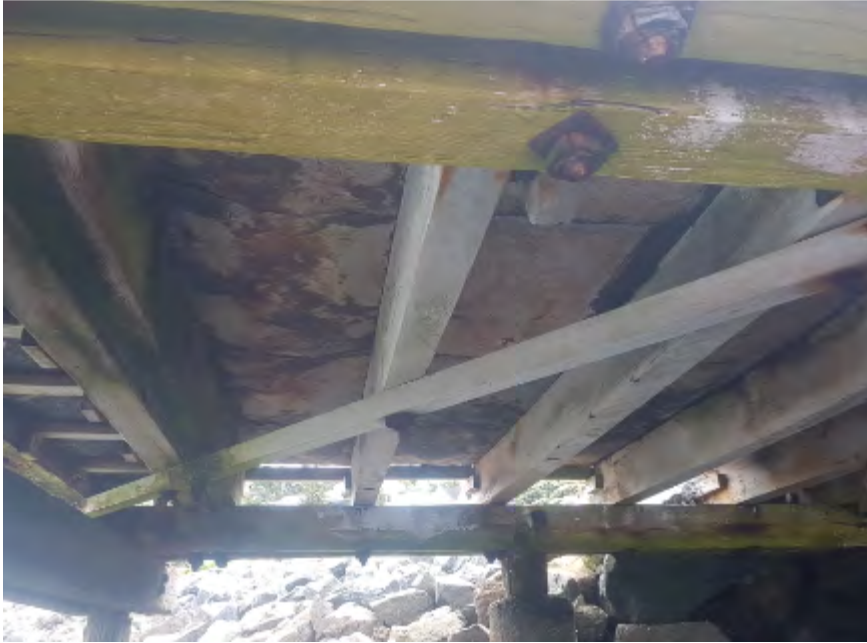
The condition of the bracing was considered reasonable compared to the condition of the bolted connections that fasten the bracings, joists and bearers; these showed signs of advanced corrosion and the onset of cross section loss in the washer plates, bolt heads and nuts. It is recommended that, in the long term, the connections are considered for replacement.

Figure 4-8. Plan Bracing of Decking in a Reasonable Condition

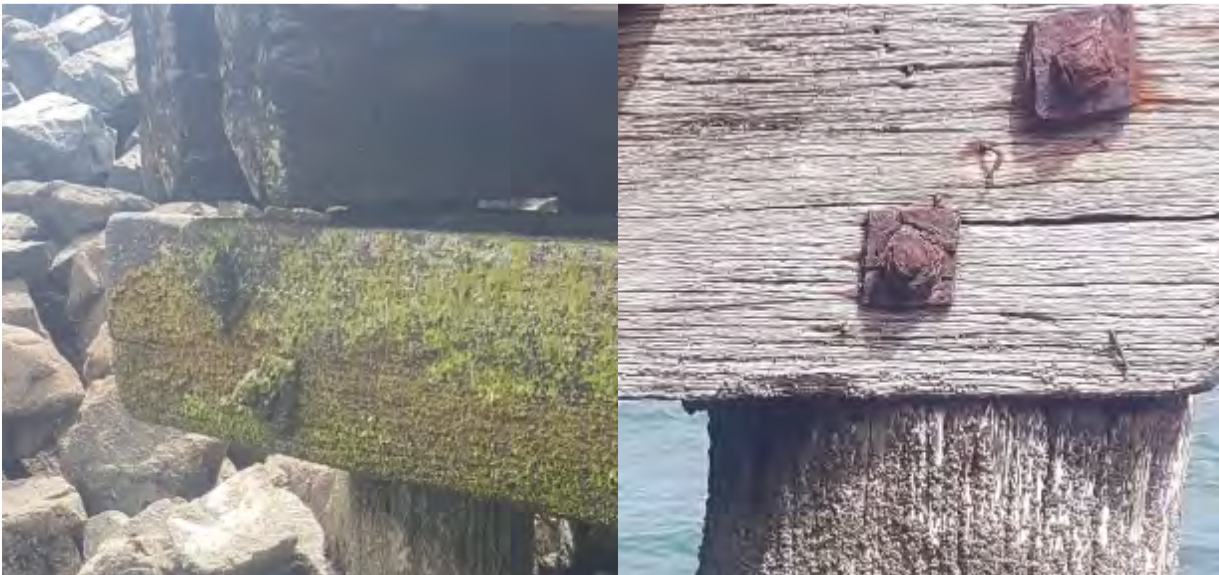
Figure 4-9. Bolted Connections

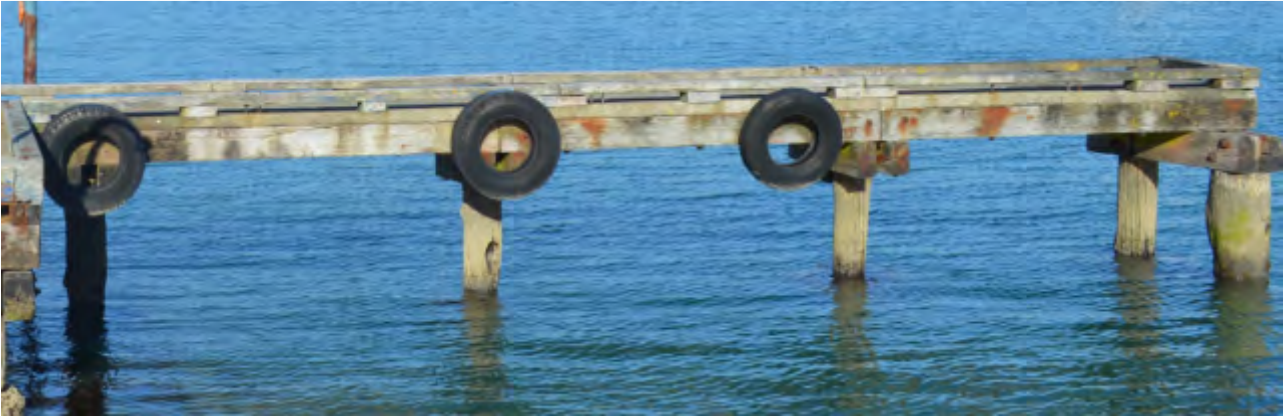
The tyre fenders in Figure 4-10 were found in a reasonable condition; however, it is suggested that WCC review whether the number and position of tyres are adequate subject to the use of the jetty.

Figure 4-10. Cog Park Jetty – Tyre Fenders

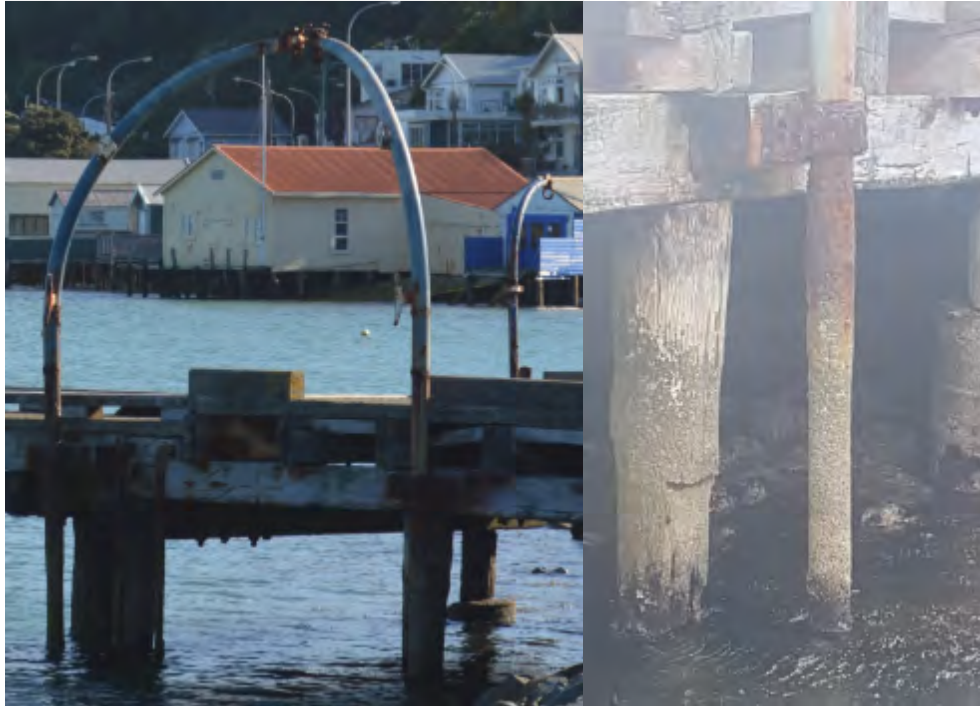
The rotating derek hoist supports in Figure 4-12 showed significant corrosion within the tidal zone. The condition of the hoist supports may be secondary considering the derek hoists are fastened together, which suggests that these supports are not in use.

Figure 4-12. Cog Park Jetty - Derek Hoists

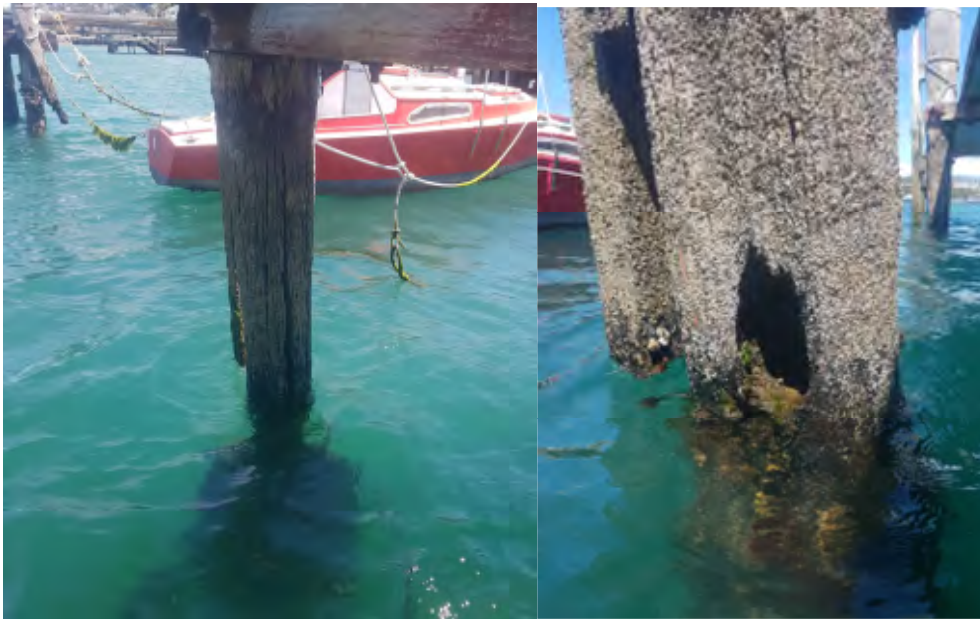
The piles were inspected visually both above and below water. Refer to Appendix A for details of the underwater visual inspection and Table 5-2 for a summary of the pile conditions. Above water several piles were found to be in a very poor condition either by having lost a significant portion of cross section or having been weakened by rot hollowing out the pile combined with significant splitting. Figure 5-3 shows to the left a typical pile with significant cross section loss and on the right a pile hollowed out by rot. It is recommended in the cases where the cross-sectional loss or rot within the piles is excessive that the piles are considered for strengthening or replacement.

Figure 5-3. Evans Bay Yacht Club North Jetty - Pile Splitting, Rot and Cross Section Loss

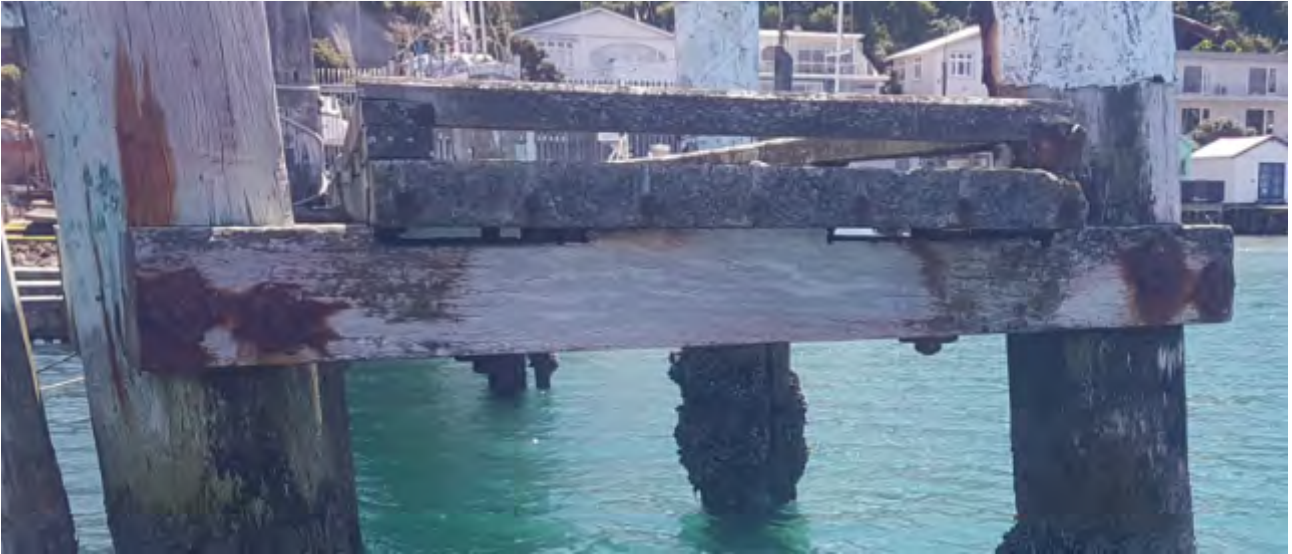
Rust staining on the bearers illustrates the ongoing corrosion of the bolted connections fastening the bearers to the piles.

Figure 5-4. Evans Bay Yacht Club Northern Jetty, End Pier Bearer

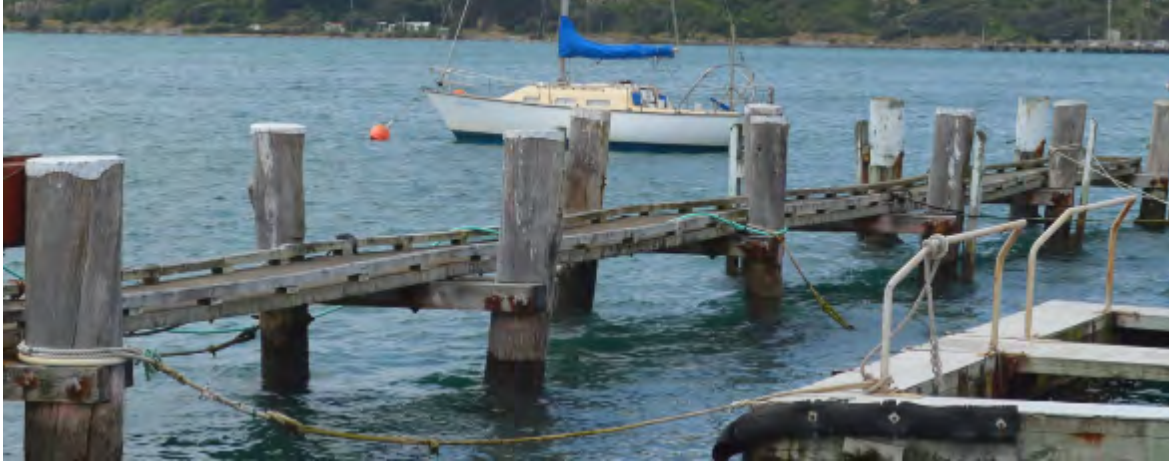
The slender concrete deck is suffering significant sagging as shown in Figure 5-6, but did not show any signs of cracking on the underside of the deck, refer Figure 5-7. However, cracking of the in-situ concrete stitch pour between deck units was observed, see Figure 5-8. This is not of major concern, and can be addressed by re-grouting in the course of scheduled maintenance.

Figure 5-6. Evans Bay Yacht Club Northern Jetty, Sagging of Decking

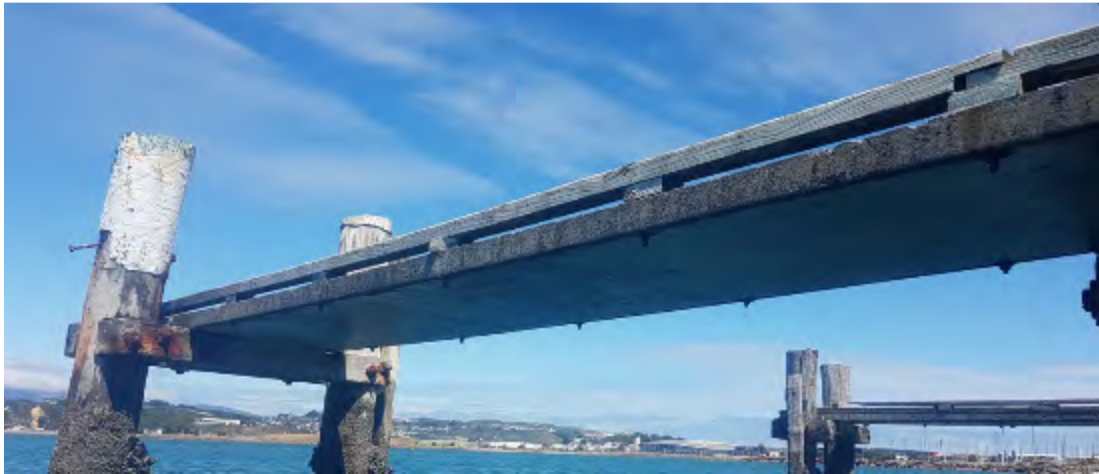
Figure 5-7. Evans Bay Yacht Club Northern Jetty - No Cracking Observed

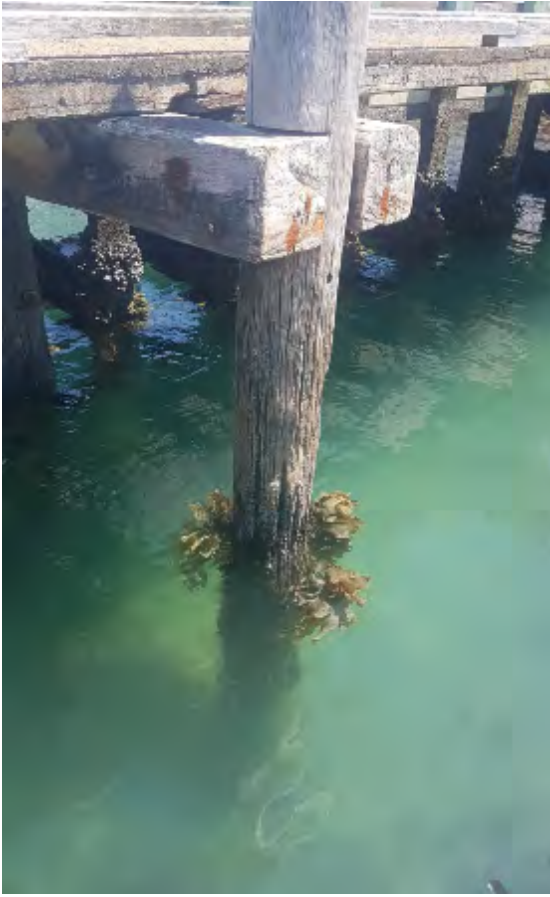
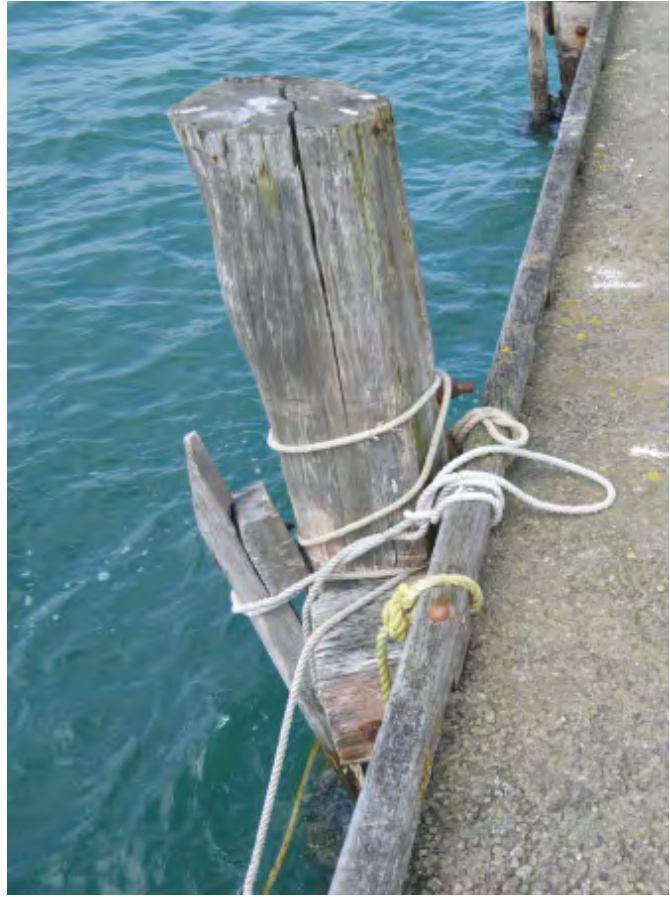
The piles were inspected visually both above and below water. Refer to Appendix A for details of the underwater visual inspection and Table 6-2 for a summary of the pile conditions. Above water several piles were found to be in a poor condition either by having lost a significant portion of cross section or having been weakened by rot hollowing out the pile combined with significant splitting. Refer to Figure 6-3 for examples of cross section loss and splitting at the top of the pile. Similar to the north jetty, hollowing out of piles due to rot from the inside as shown in Figure 6-4, was encountered.

Figure 6-3. Evans Bay Yacht Club South Jetty - Splitting of Piles

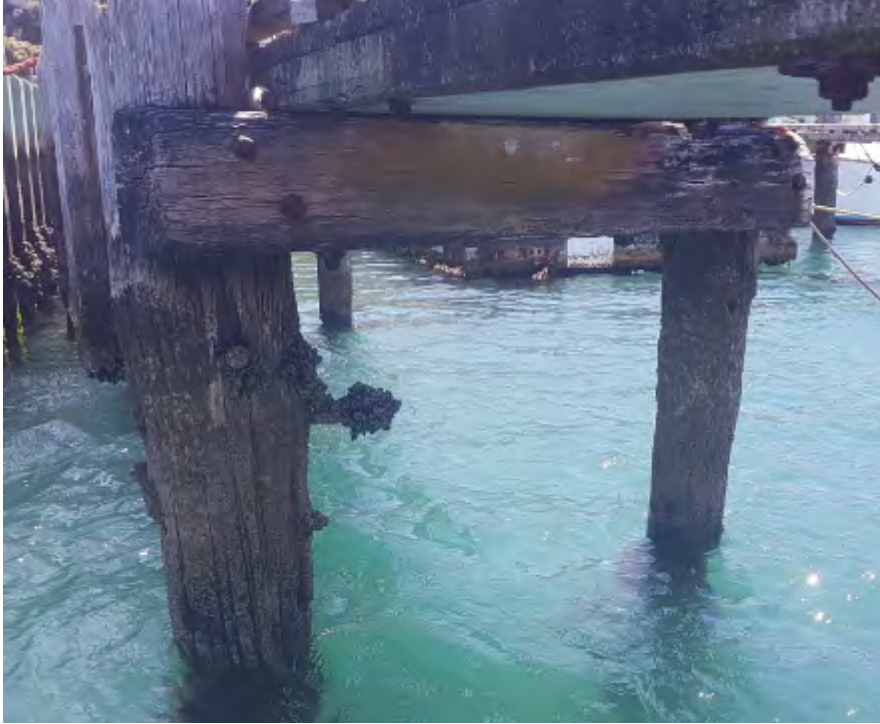
The bearers showed varying levels of splitting with more extensive splitting at the ends of the bearers, refer Figure 6-5. However no signs of distress were observed, such as extensive sagging of the bearer.

Figure 6-5. Evans Bay Yacht Club South Jetty - Bearers

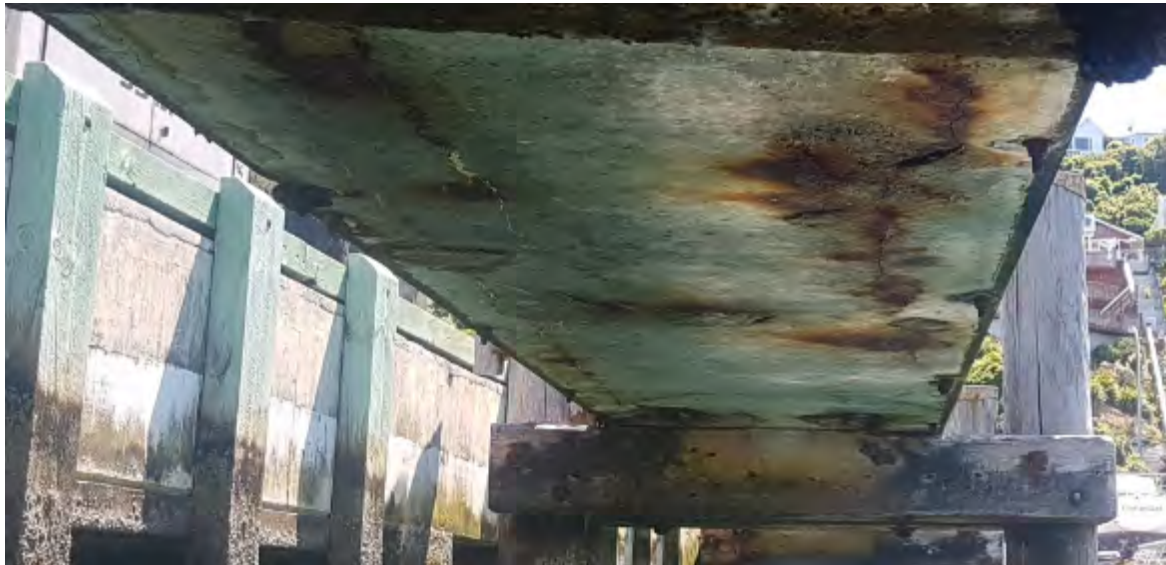
Figure 6-7. Evans Bay Yacht Club South Jetty - Underside of Decking

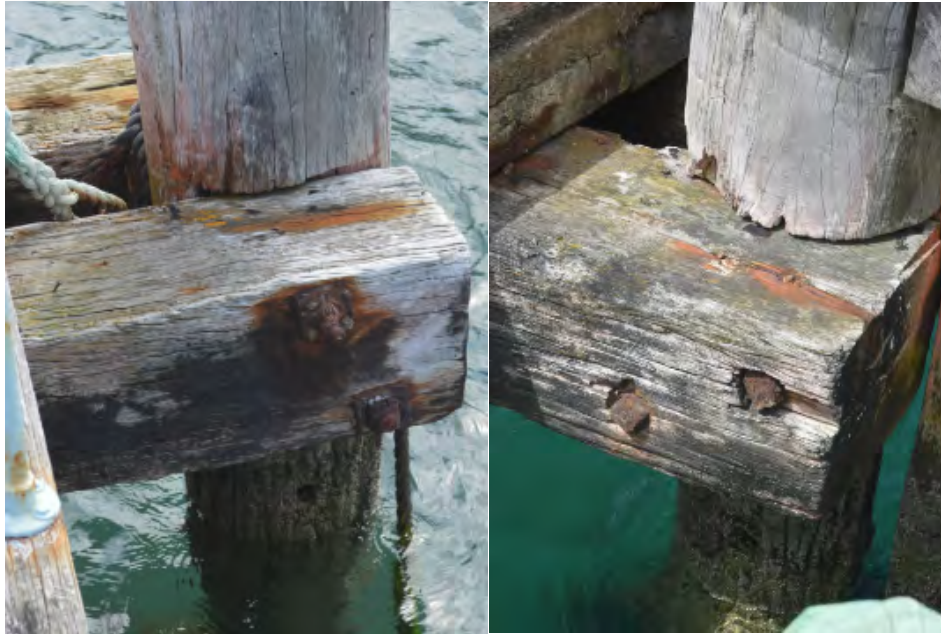
Figure 6-8. Evans Bay Yacht Club South Jetty - Advanced Corrosion of Bolted Connections

Corrosion of the all the bolted connections was advanced and replacement of the bolted connections with stainless connections should be considered.

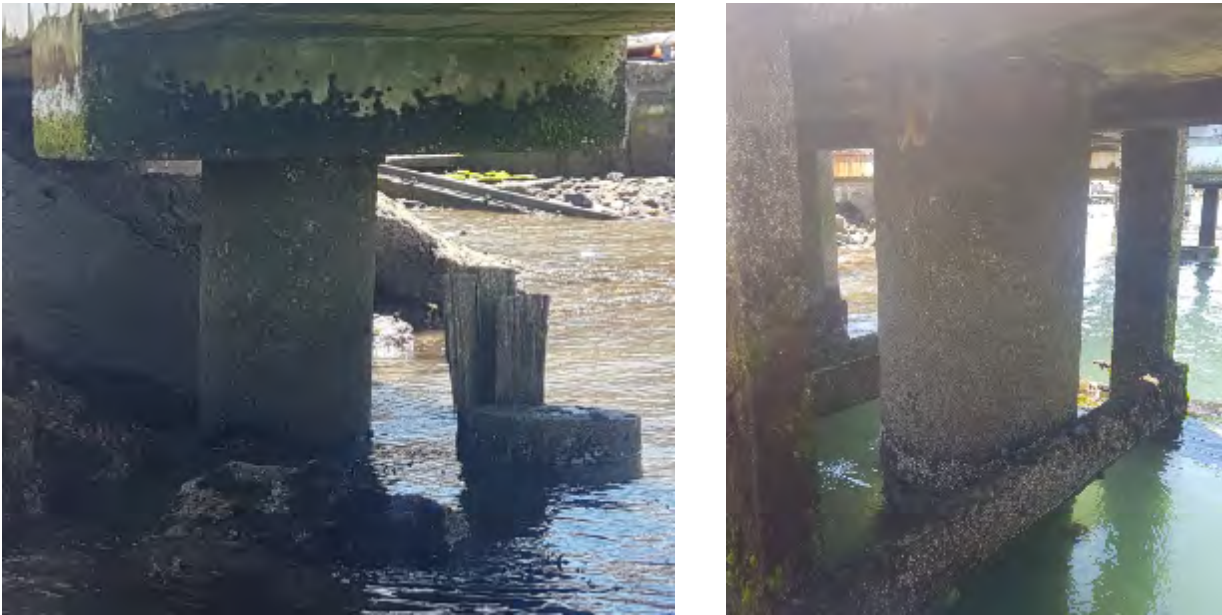
The piles were inspected visually both above and below water. Refer to Appendix A for details of the underwater visual inspection and Section 7.4 for a summary of the pile conditions. Besides expected marine growth and pitting of the steel cladding, the concrete piles were found to be in a good condition above and below water, refer to Figure 7-2.

Figure 7-3. Evans Bay Yacht Club Travel Lift – Steel Clad Concrete Piles In Good Condition

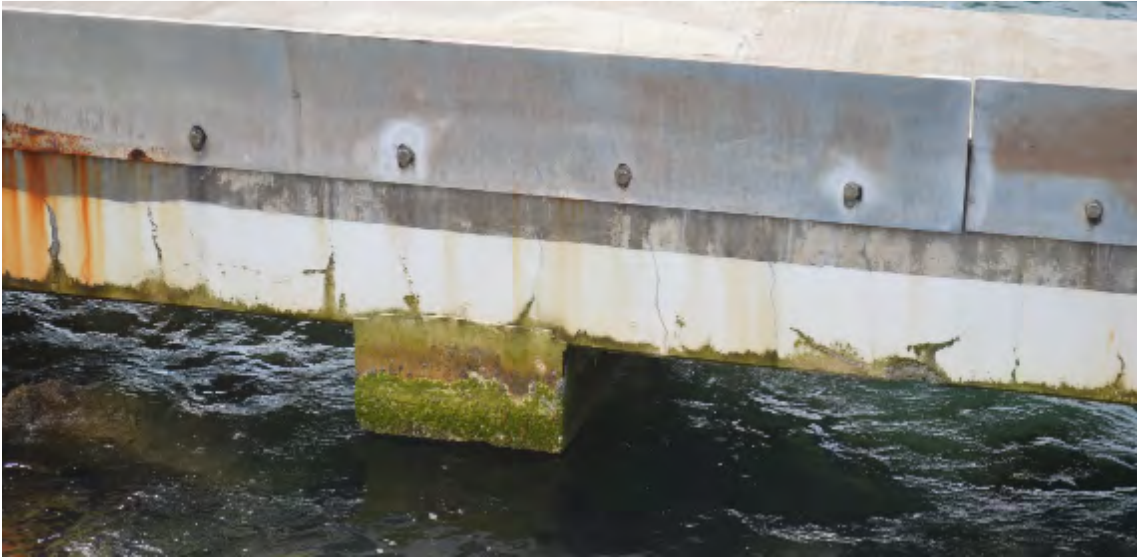
Figure 7-4. Evans Bay Yacht Club Travel Lift - Vertical Cracking on Inside Face of Northern Platform

It is recommended, that these cracks are monitored to confirm if they are signs of distress resulting from ongoing use of the travel lift. It is considered that the cracks may have resulted as part of the damage that was investigated in 2010 and resulted in retro fitting intermediate piles to the structure; the investigation results seem to indicate this.

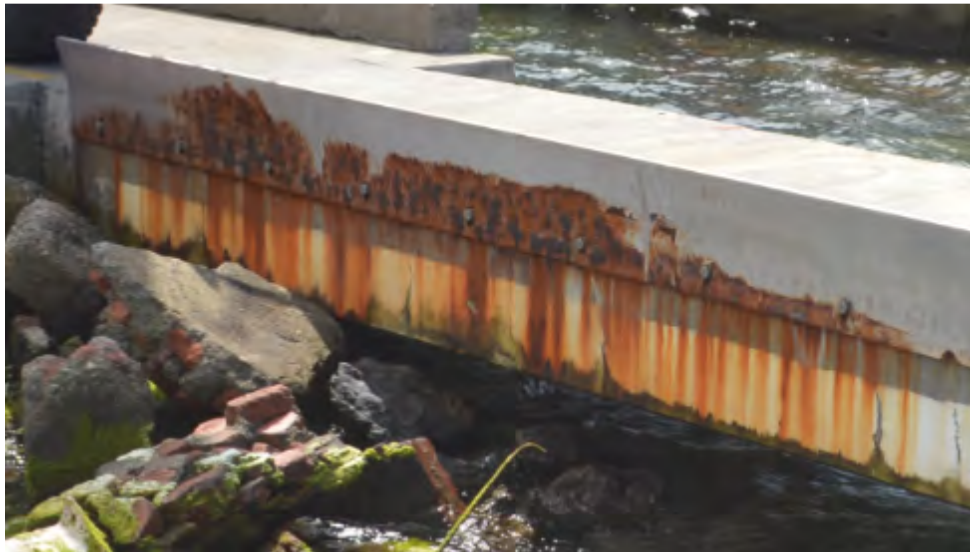
Furthermore, localised rust staining due to ongoing corrosion of the north side travel platform toe backing planks was observed. Refer Figure 7-5. It appears at this location, the protective galvanised coating has degraded, exposing the steel planks to sea water. As part of regular maintenance, the two planks in question could be unbolted, rust removed and re-galvanised.

Figure 7-5. Evans Bay Yacht Club travel lift, localised corrosion and rust staining of side mounted steel planks

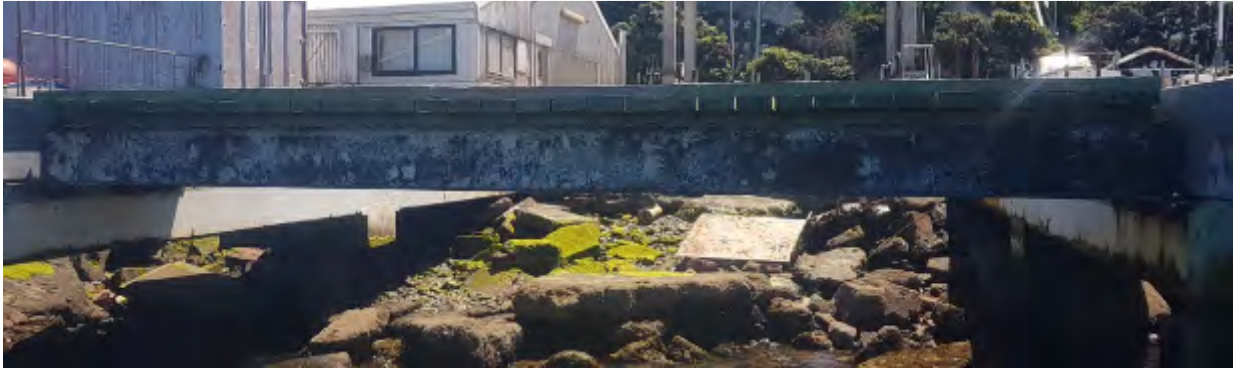
Figure 7-6. Evans Bay Yacht Club Travel Lift - Traverse Access Platform, Steel Beams, Degradation of Paint System

It is recommended that the platform is unbolted, steel beams sand blasted to remove any flaking paint and onset of rust, and re-painted.

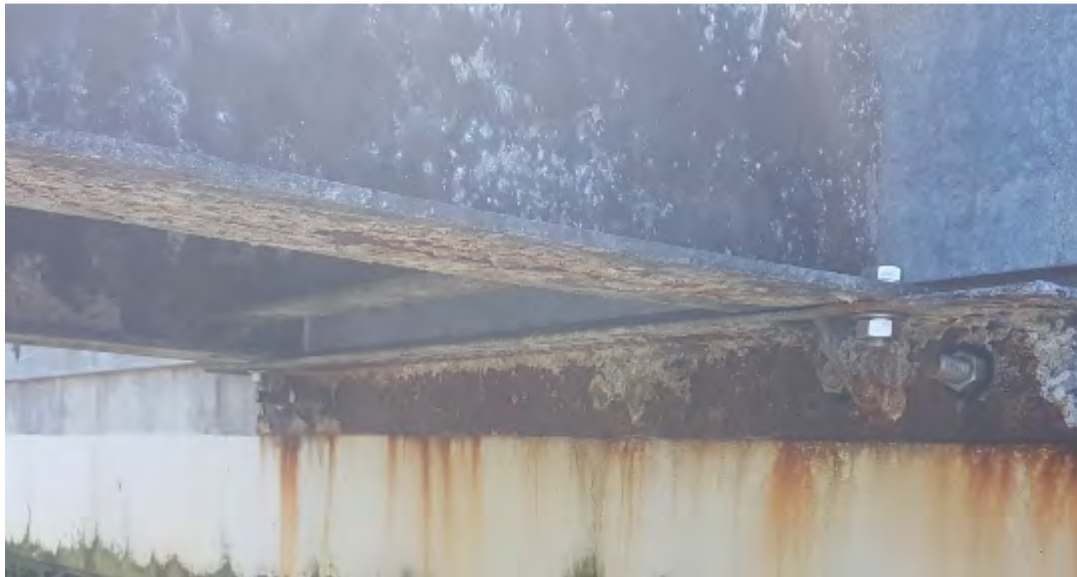
All stainless steel bolted connections fastening the traverse access platform and fenders, appeared to be in a good condition without the need for immediate maintenance actions. Refer to Figure 7-7.

Figure 7-7. Evans Bay Yacht Club Travel Lift - Retrofitted Stainless Steel Connections

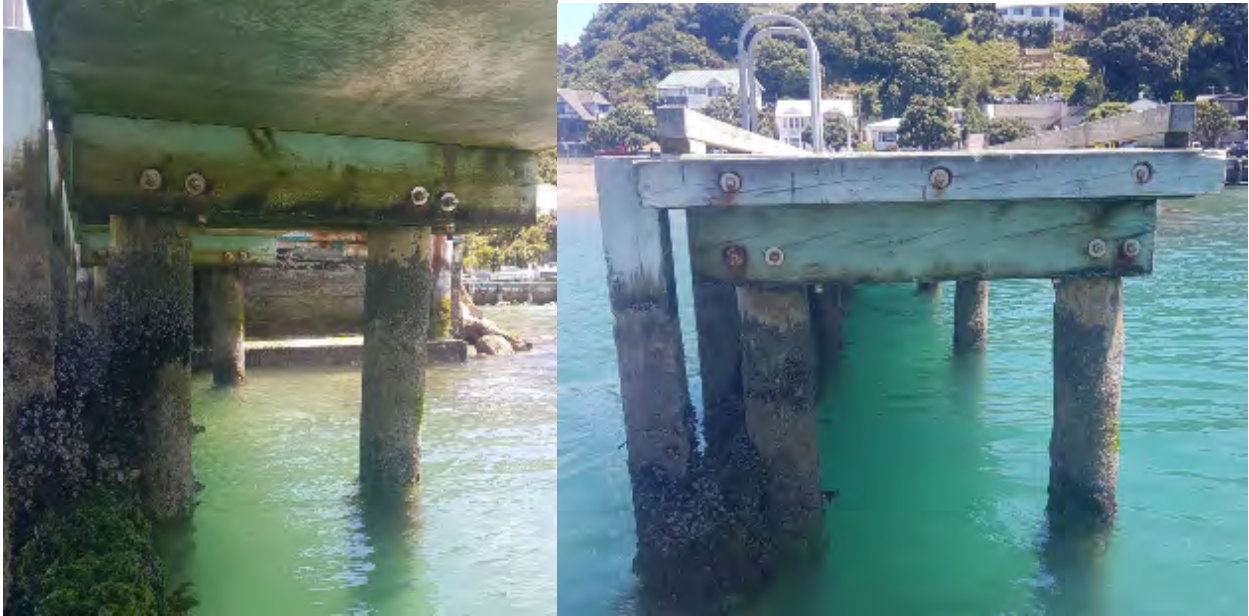
As shown in Figure 8-3 the piles were found in a good condition, besides typical marine growth. As part of regular maintenance, removal of marine growth could be considered.

Figure 8-3. Evans Bay Boat Ramp North Jetty Piles

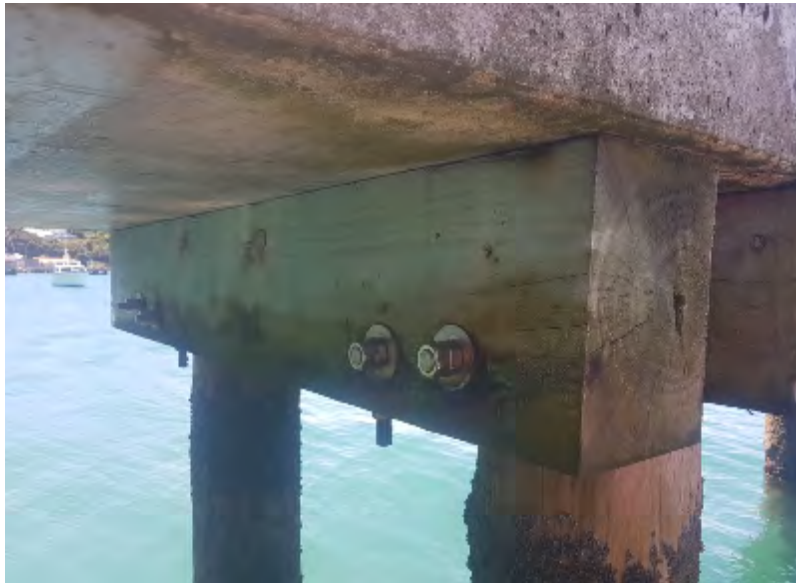
Both the bearers and stainless steel bolted connections, as shown in Figure 8-4 were found in a very good condition with no maintenance actions required.

Figure 8-4. Evans Bay Boat Ramp North Jetty, Bearers and Connections

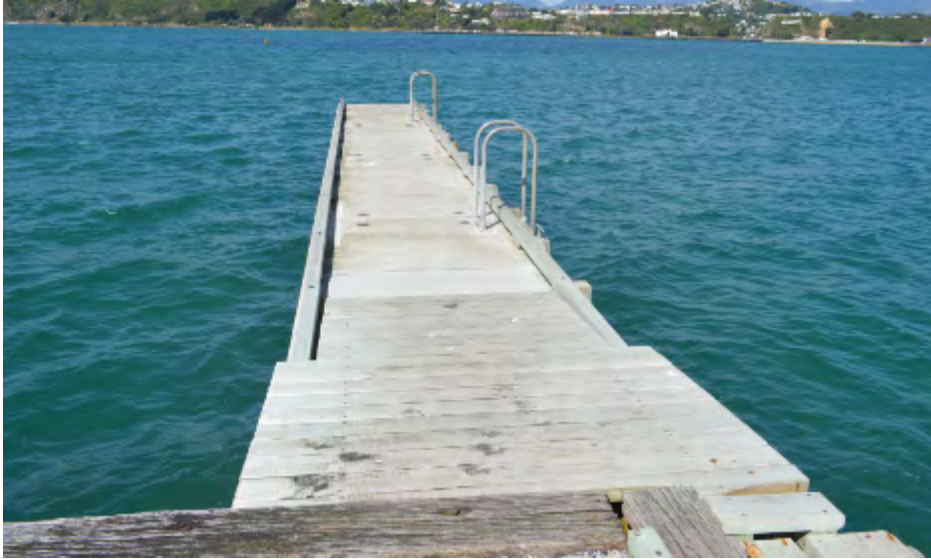
As shown in Figure 8-5, the concrete decking is in a very good condition. The same applies to the timber ramp leading from the main boat ramp to the concrete decking.

Figure 8-5. Evans Bay Boat Ramp North Jetty - Timber Decking

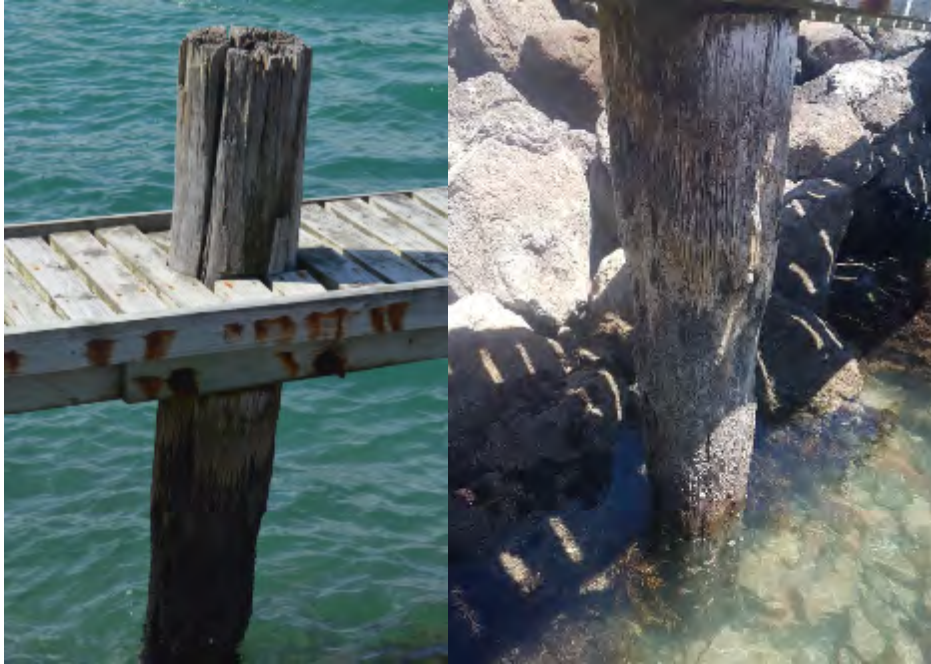
Figure 9-3. Evans Bay Boat Ramp South Jetty - Loss of Cross Section and Splitting of Timber Piles

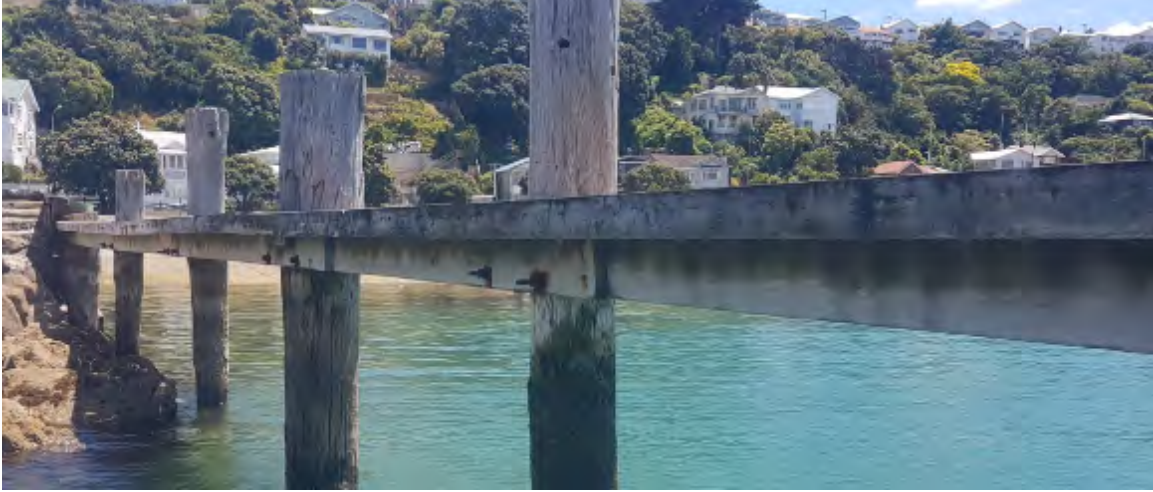
Figure 9-4. Evans Bay Boat Ramp South Jetty – Overlapping of Decking Joists

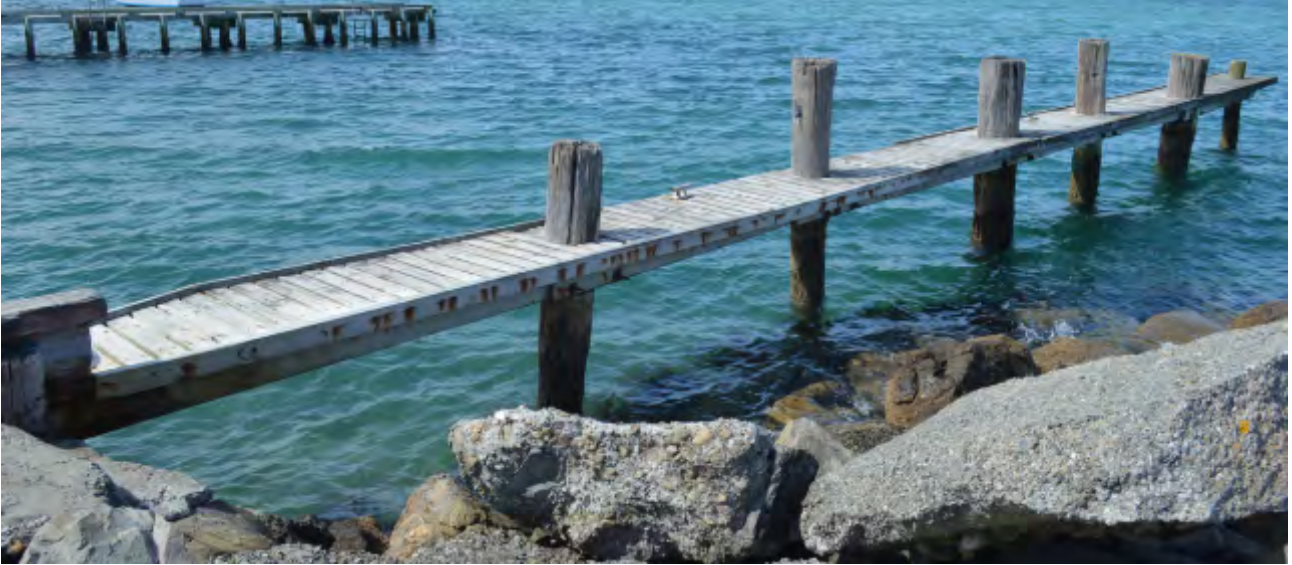
Figure 9-6. Evans Bay Boat Ramp South Jetty, decking

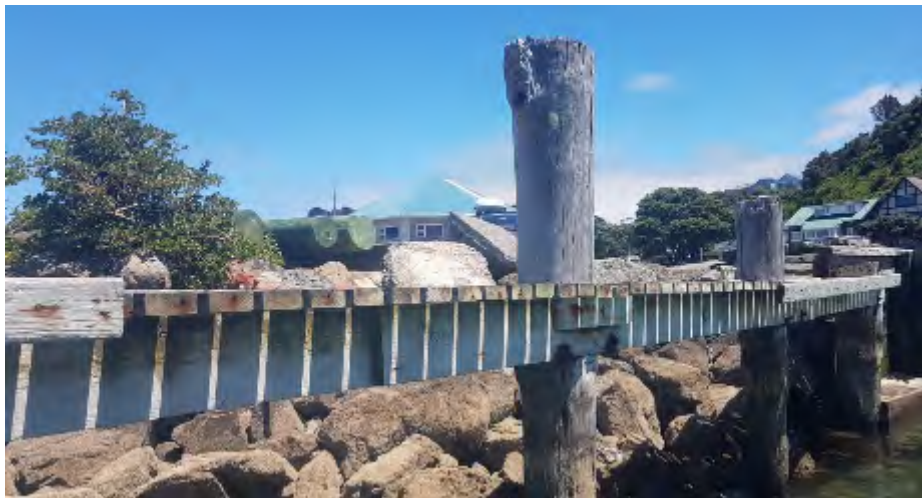
Further defects comprised splitting of one of the end span joists leading to a piece of timber breaking off and a decking edging plank missing between the 2nd and 4th pile on the northern side of the decking, both of which are recommended to be replaced.

Figure 9-7. Evans Bay Boat Ramp South Jetty – Missing Deck Edging Plank
