WCC Marine Assets Structural Condition Assessment 2017

Prepared for Wellington City Council

Prepared by Beca Limited

29 March 2018

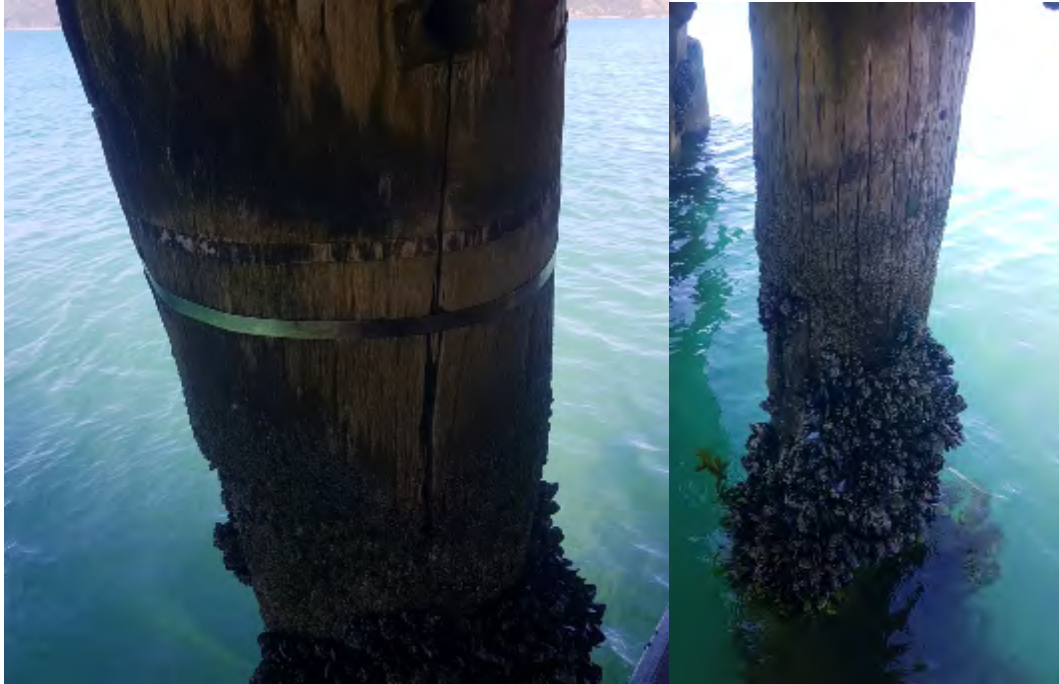
The piles which are concrete encased appeared to be in a better condition than the timber piles completely exposed to seawater, in particular within the tidal zone, resulting in significant rot, cross section loss and splitting of the exposed piles.

Figure 10-3. Seatoun Wharf - Splitting and Cross Section Loss of Non-Encased Timber Piles

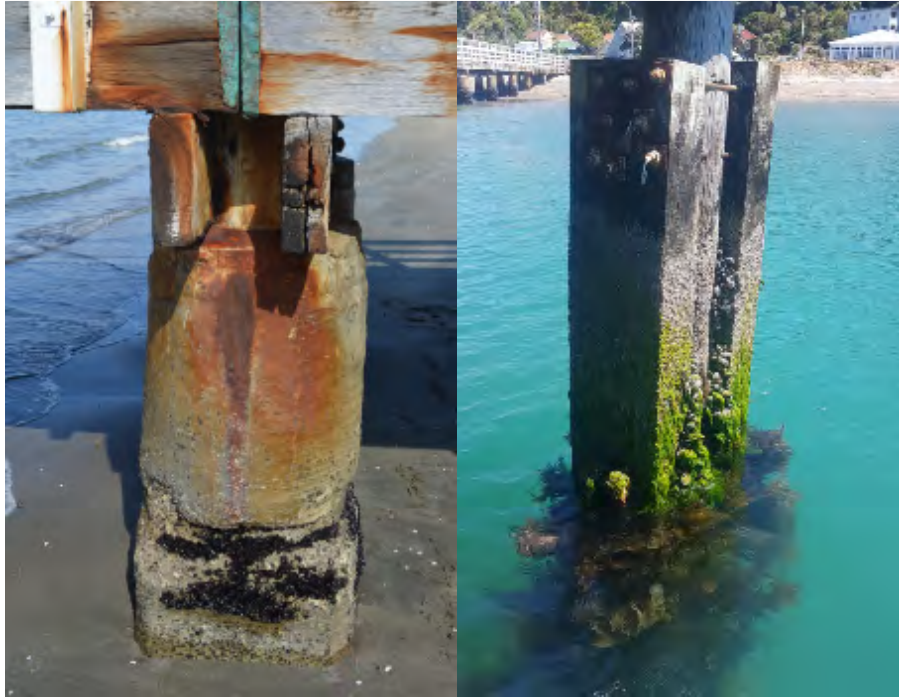
Figure 10-4. Seatoun Wharf – Left, Concrete Encased Timber Piles, Right, Previous Repair of Timber Piles By Sistering

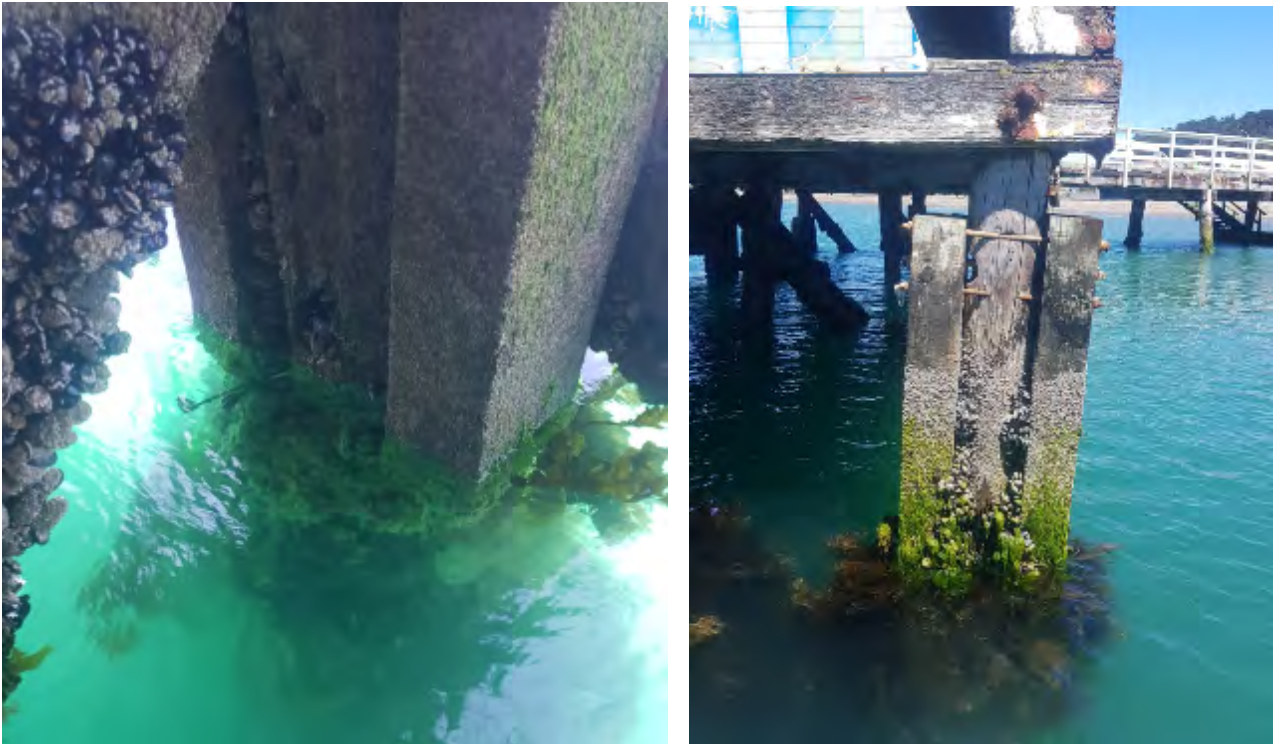
It was observed that previous pile repairs comprising sistering of timber joists to existing timber piles stopped short of being embedded into the marine bed. These instead beared on concrete encased pile sockets above marine bed level. Therefore, these pile repairs were not considered to be providing continuity across the weakened pile section. Hinging of these sistered piles in conjunction with severely deteriorated timber bracing may have led to a lateral shunting of the ferry landing platform piles which was observed.

Figure 10-5. Seatoun Wharf - Left, Sistering of Existing Timber Piles Not Fully Extending to Marine Bed. Right, Lateral Shunting of Sistered Piles

In light of the shunting and inclination of the timber piles observed, it appears the lateral stability of the landing platform to cater for ferry mooring loads is compromised. Repair of existing or installation of replacement piles with adequate embedment into the marine bed, along with new timber bracing supporting and restraining the landing platform, should be considered.

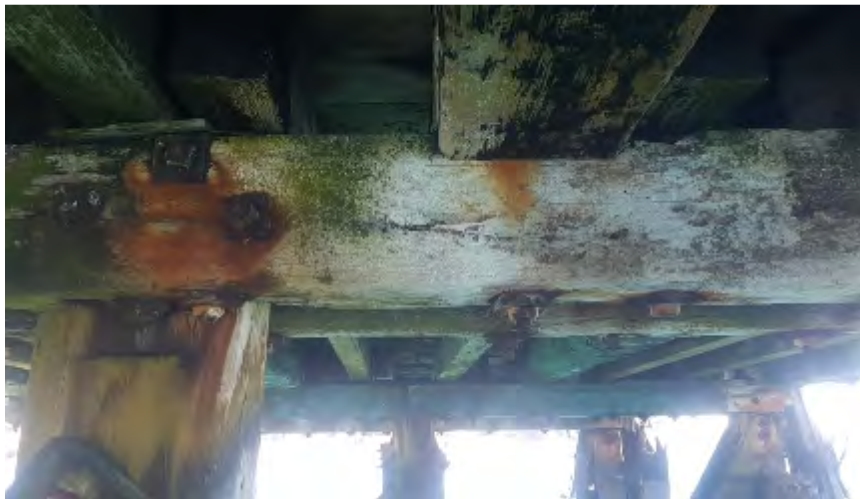
Figure 10-7. Seatoun Wharf - White Rot on Bearer, D2-E2

Furthermore, white rot was encountered on one of the bearers supporting the landing platform. No other signs of distress to this bearer were observed. However, it is recommended that the white rot is treated to stop it spreading and a timber sample is taken to check the penetration of the rot. Further assessment of the condition of the joist can result from this sampling.

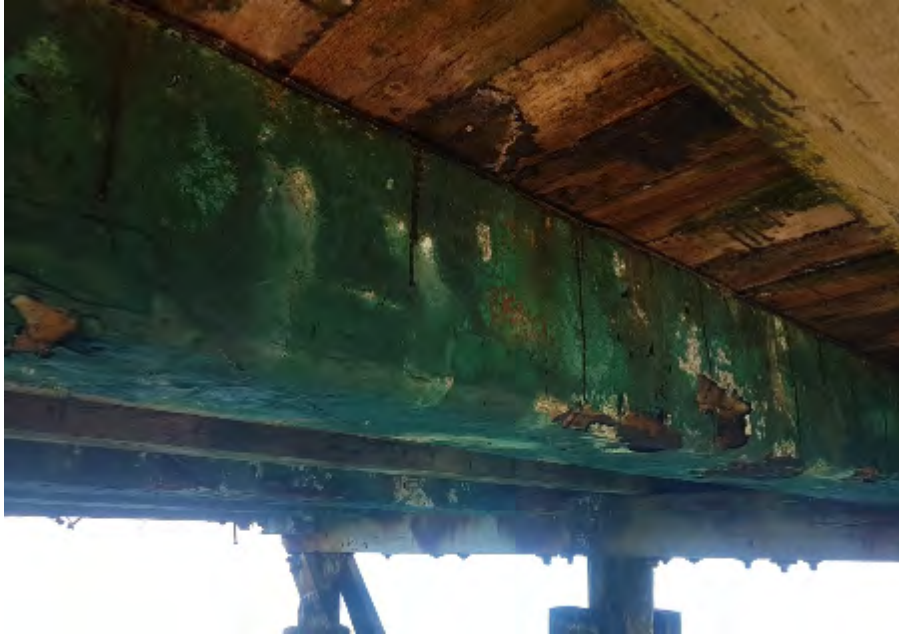
Figure 10-8. Seatoun Wharf – Copper Cladding on Joist

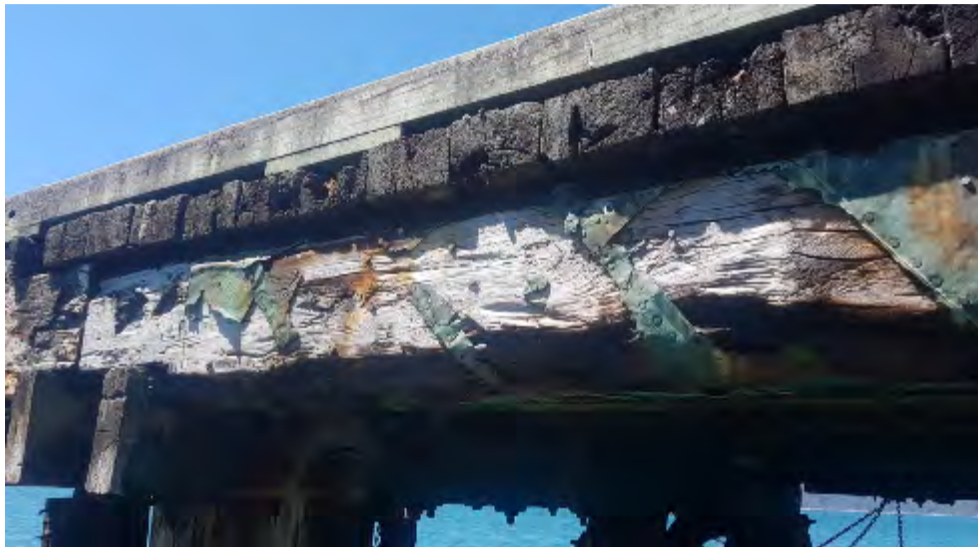
Figure 10-9. Seatoun Wharf – Torn and Missing Copper Cladding, and White Rot on External Bearer, C3-C4

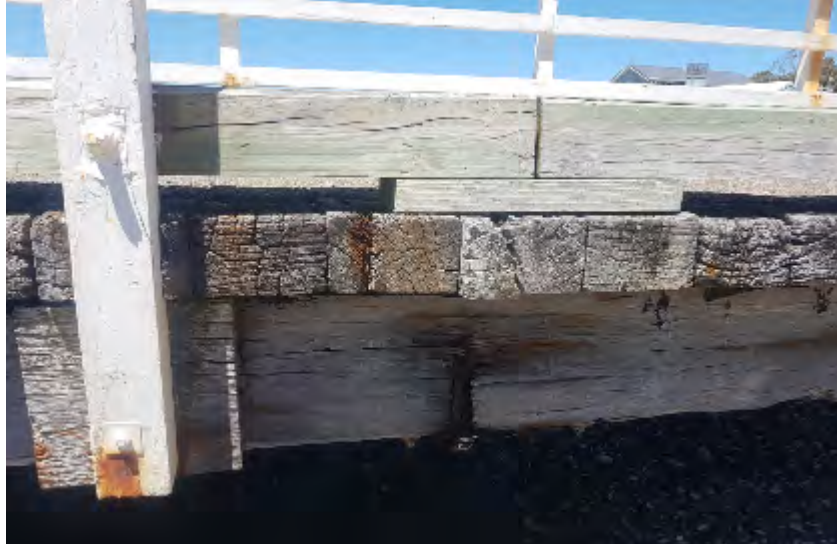
Figure 10-10. Seatoun Wharf – End Splitting of Decking Planks

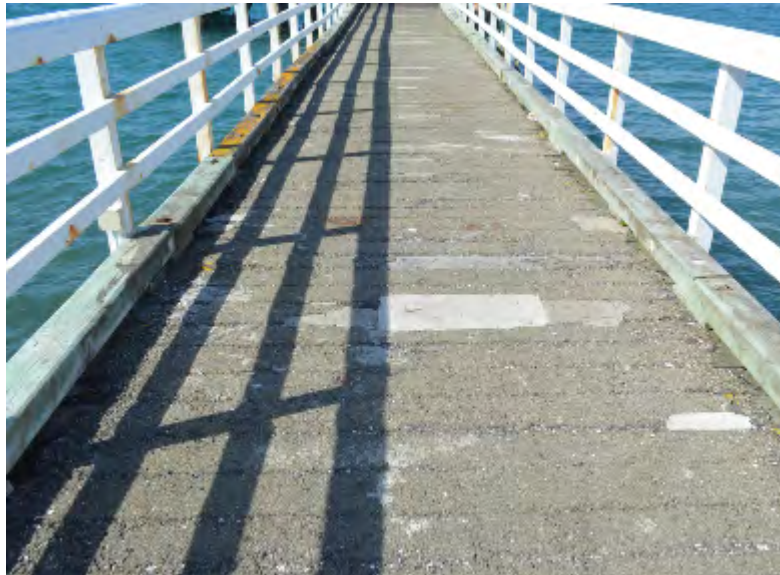
Figure 10-11. Seatoun Wharf – Cracking in Deck Surfacing

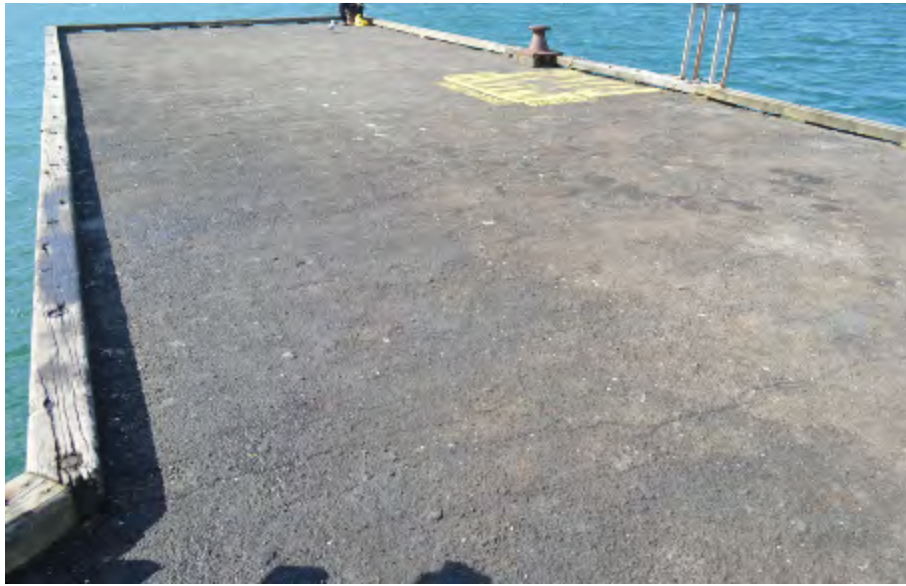
Figure 10-12. Seatoun Wharf – Mooring Platform Decking

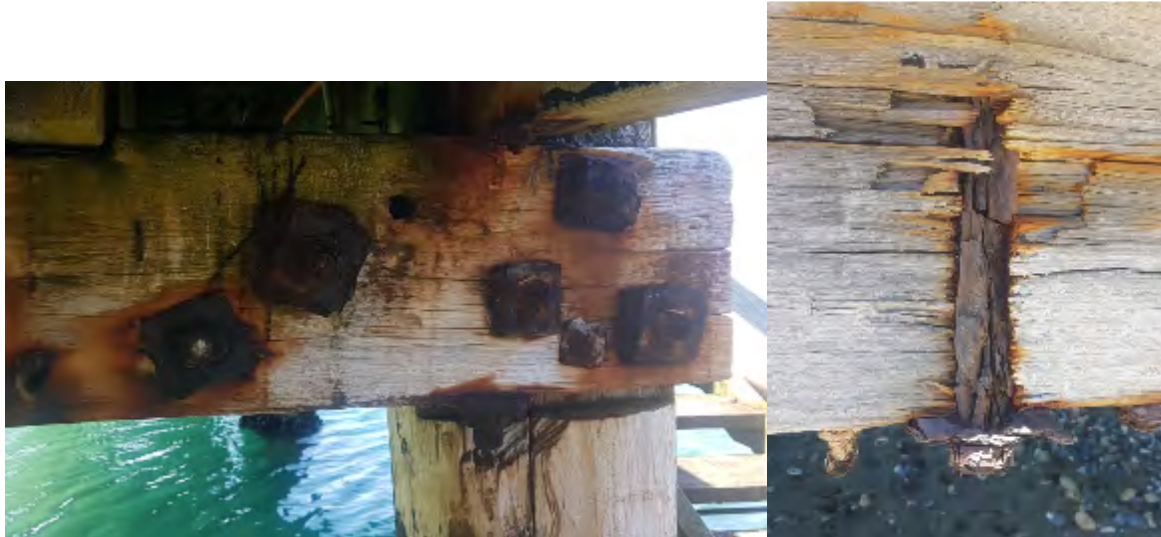
Figure 10-13. Seatoun Wharf, Observed poor condition of bolted connections

Finally, all the bolted connections showed advanced deterioration due to corrosion and should be replaced as part of wharf maintenance.

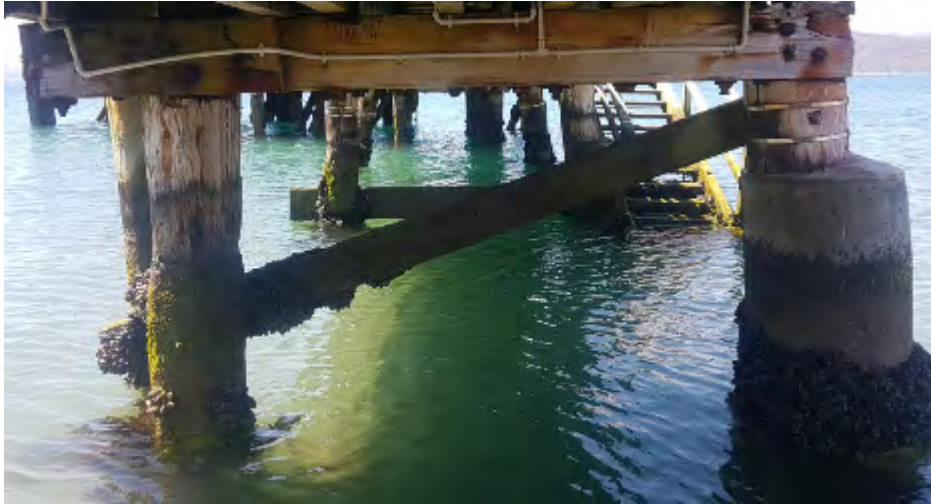
Figure 10-14. Seatoun Wharf – Bracing of Access Jetty

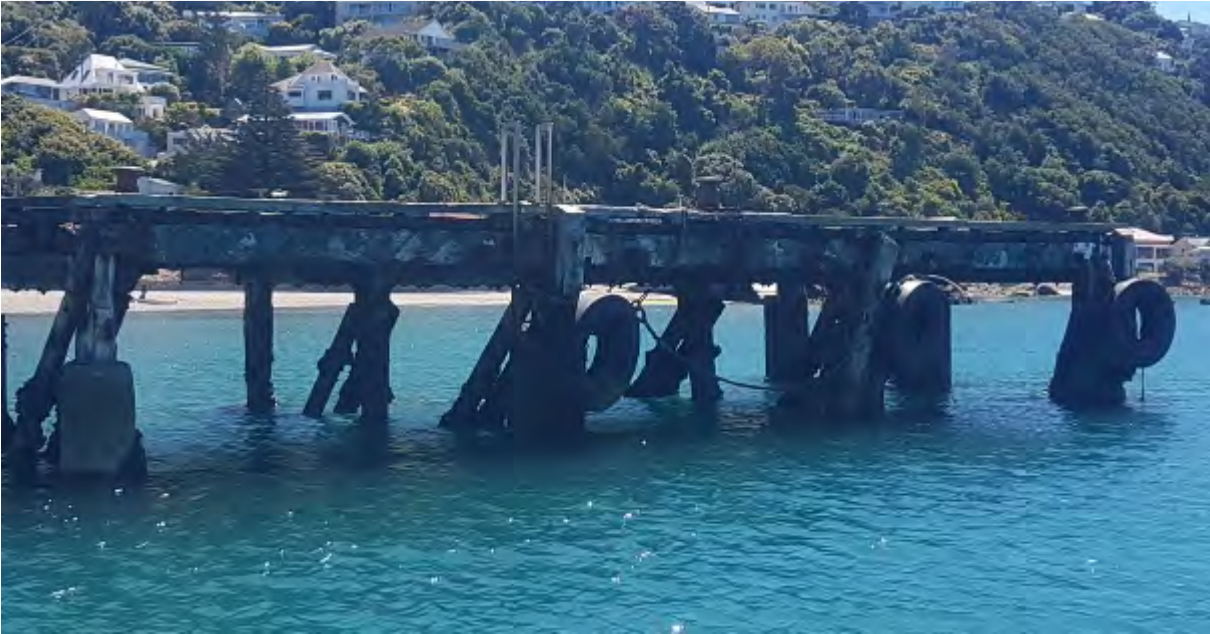
Figure 10-16. Seatoun Wharf - Fenders

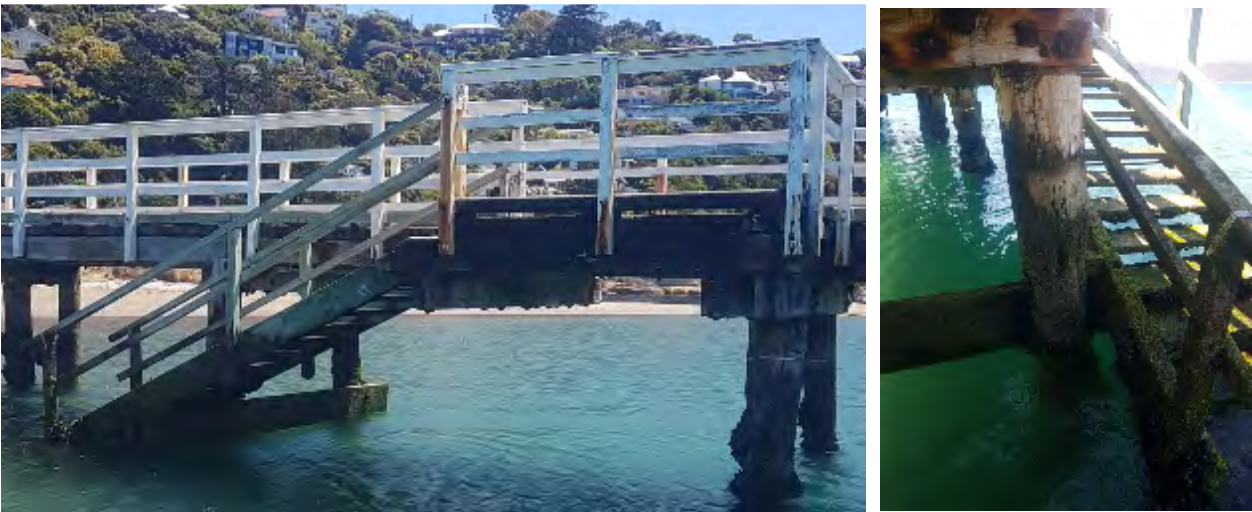
Figure 10-17. Seatoun Wharf - Stairs

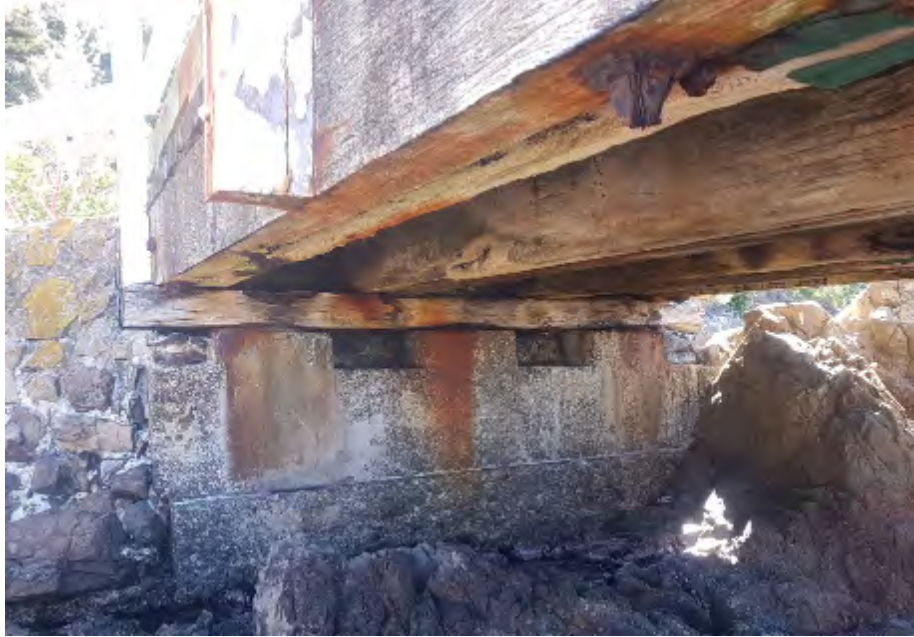
Figure 11-3. Karaka Bay Wharf – Concrete Abutment

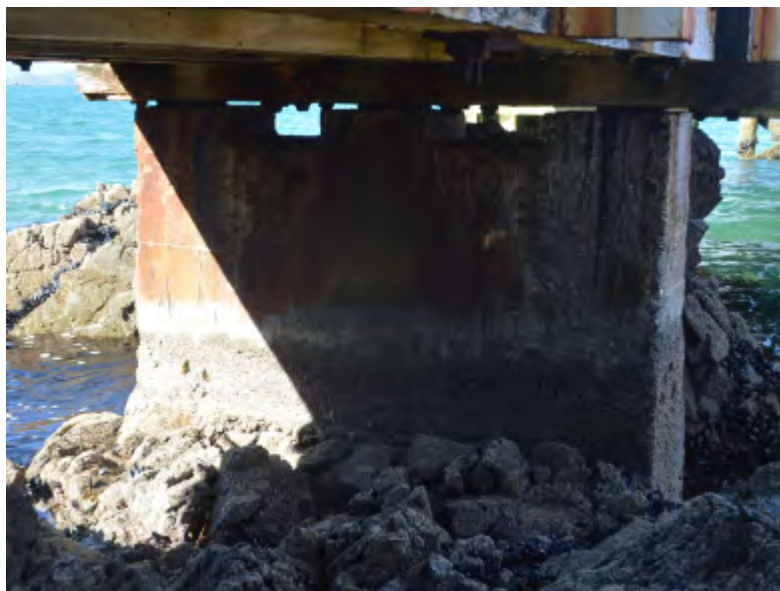
Figure 11-4. Karaka Bay Wharf – Concrete Pier

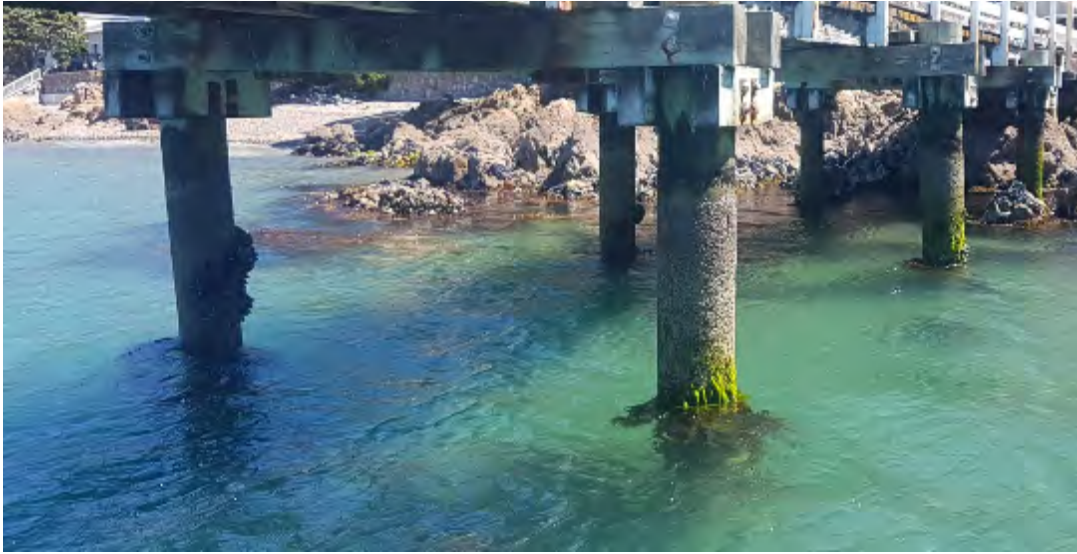
Figure 11-5. Karaka Bay Wharf – Retrofitted Under Pinned Piers

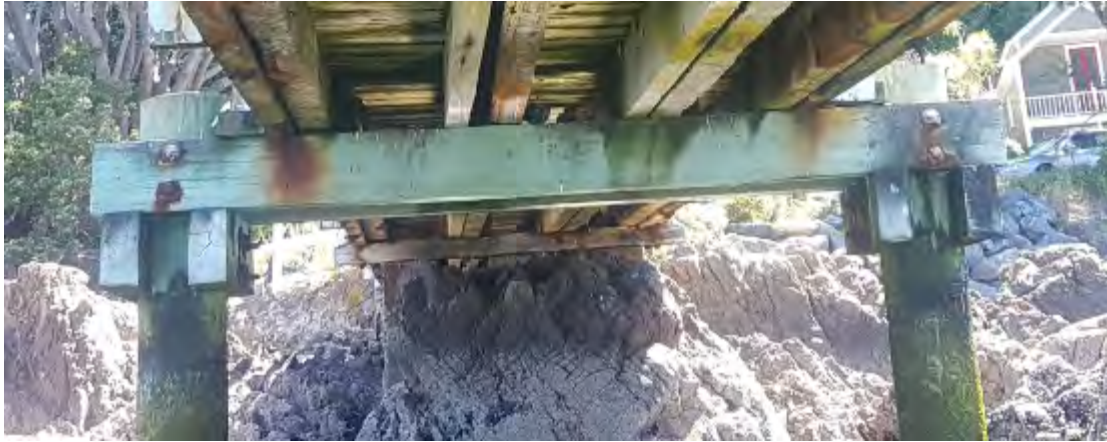
Figure 11-7. Karaka Bay Wharf – Bearers of Underpinned Piers

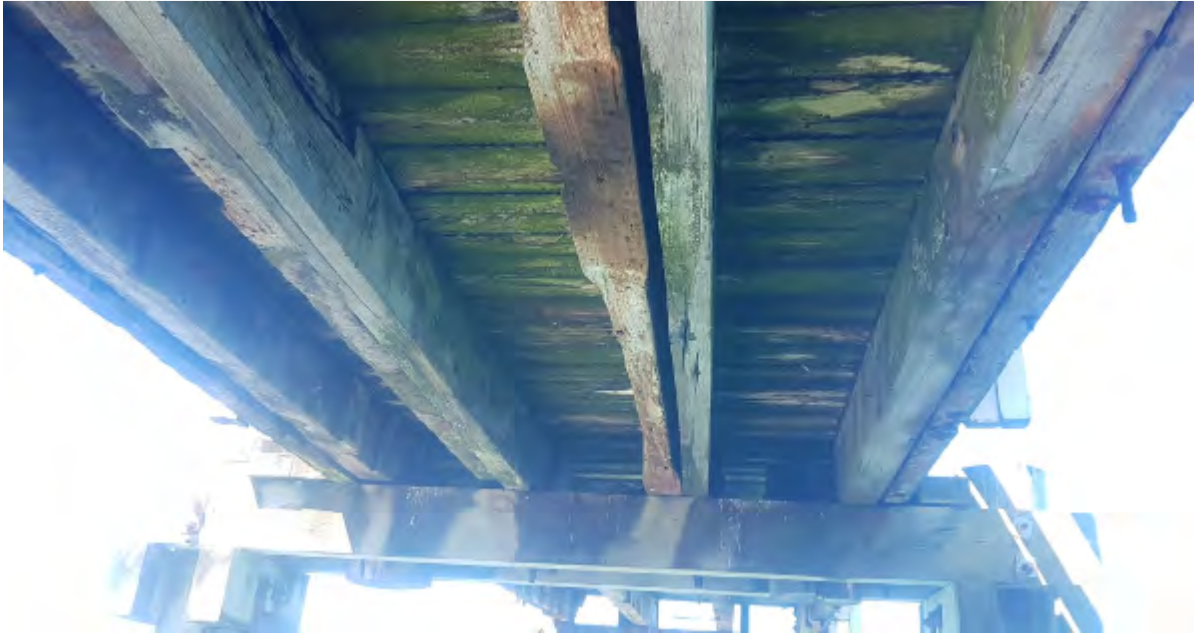
Figure 11-9. Karaka Bay Wharf – Sistered Joists on Intermediate Spans

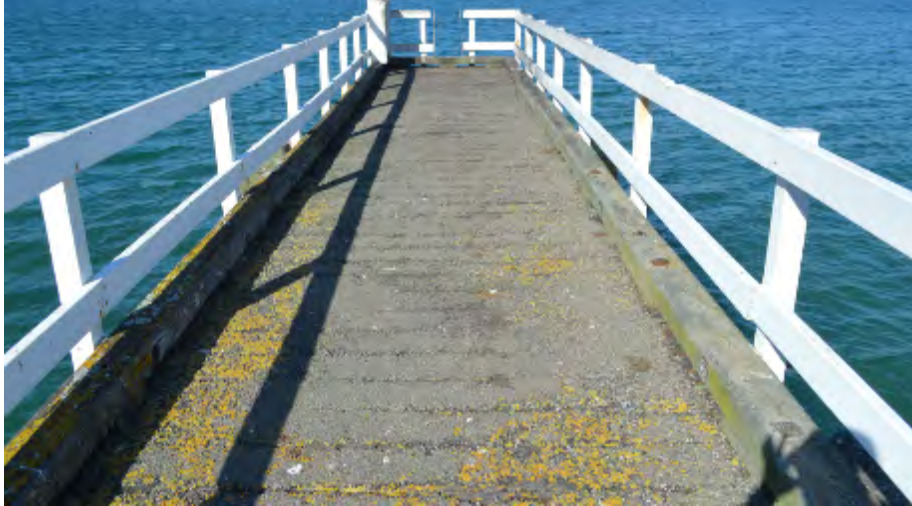
Figure 11-13. Karaka Bay Wharf – Top Side of Decking and Handrails

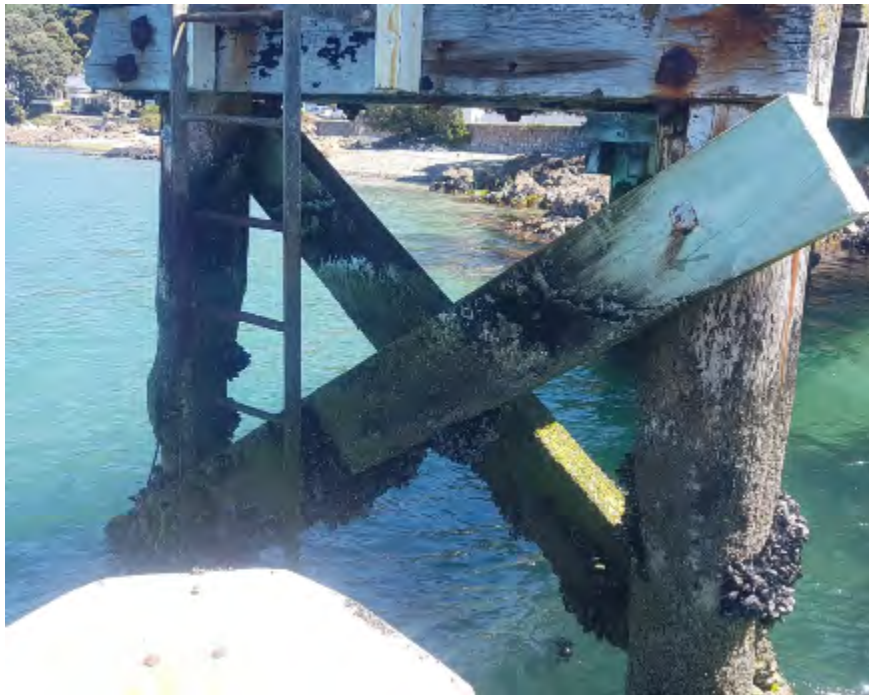
Figure 11-14. Karaka Bay Wharf – Bracing at End Piles

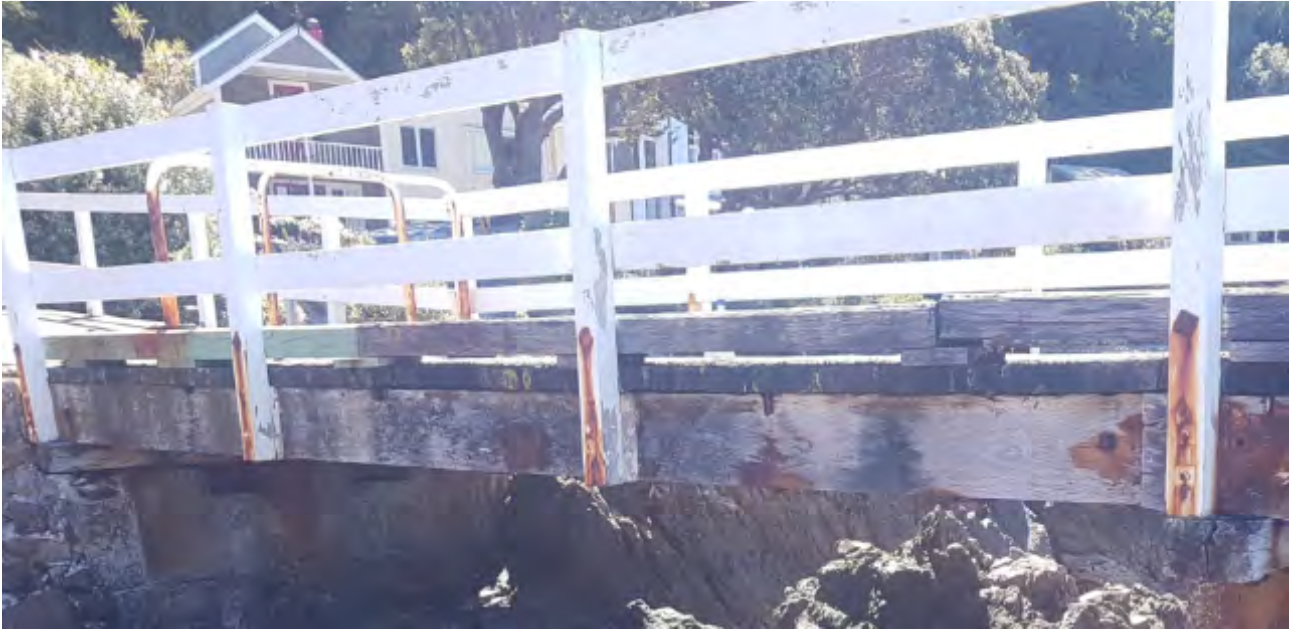
Figure 11-17. Karaka Bay Wharf - Handrail
