WCC Marine Assets Structural Condition Assessment 2017

Prepared for Wellington City Council

Prepared by Beca Limited

29 March 2018

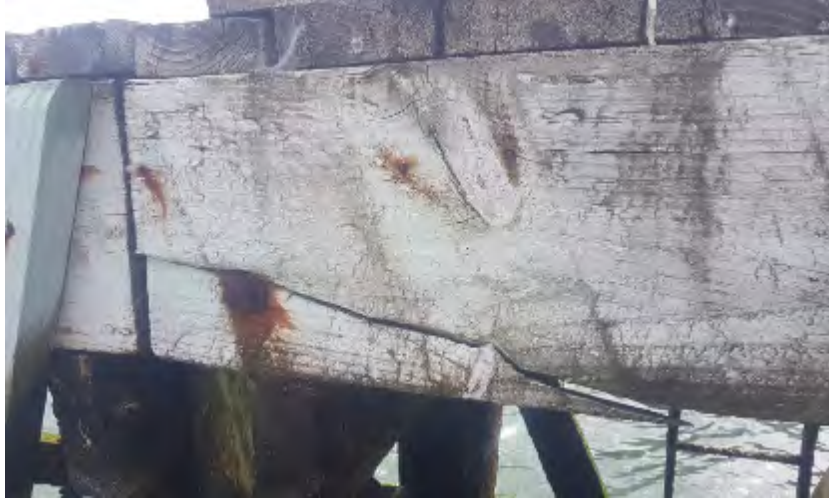
Figure 2-4. Greta Point Wharf - Splitting of Joist

All timber decking joists and bearers were found overall in a reasonable condition. Only in very few instances was splitting at the ends of decking joists encountered as illustrated in Figure 2-4.

In these instances it would be recommended to replace the timber joists.

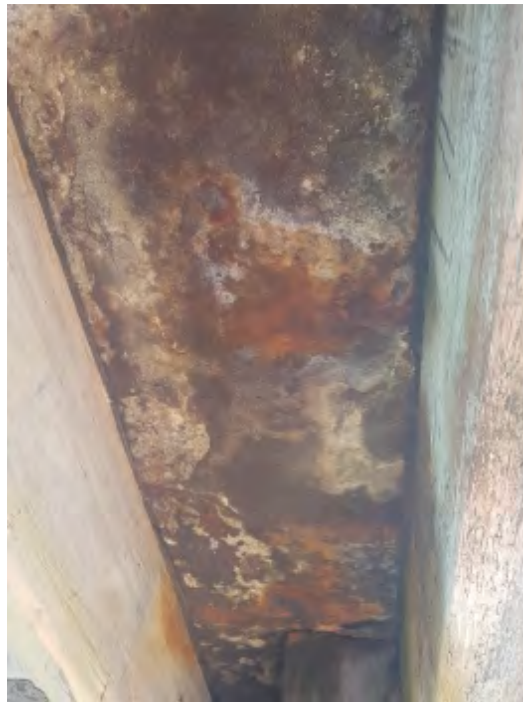
Figure 4-7. Cog Park Jetty - Underside View of Concrete Deck With Advanced Corrosion of Steel Soffit Formwork

The concrete deck was considered to be in a reasonable condition, as illustrated in Figure 4-6. The sacrificial soffit steel formwork was severely corroded, see Figure 4-7, however without any noticeable consequence to the performance of the deck, which showed no signs of distress such as cracking.

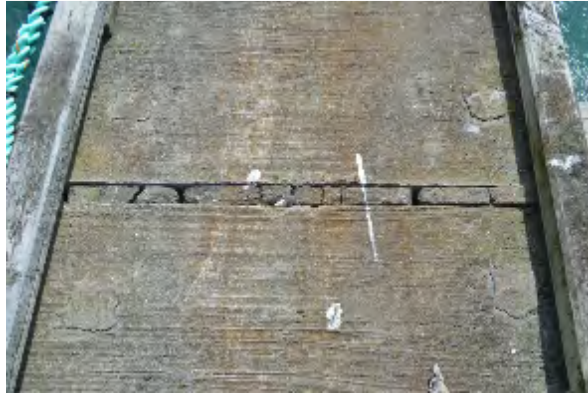
Figure 5-8. Evans Bay Yacht Club Northern Jetty - Cracking of Concrete Decking Stitches

The slender concrete deck is suffering significant sagging as shown in Figure 5-6, but did not show any signs of cracking on the underside of the deck, refer Figure 5-7. However, cracking of the in-situ concrete stitch pour between deck units was observed, see Figure 5-8. This is not of major concern, and can be addressed by re-grouting in the course of scheduled maintenance.

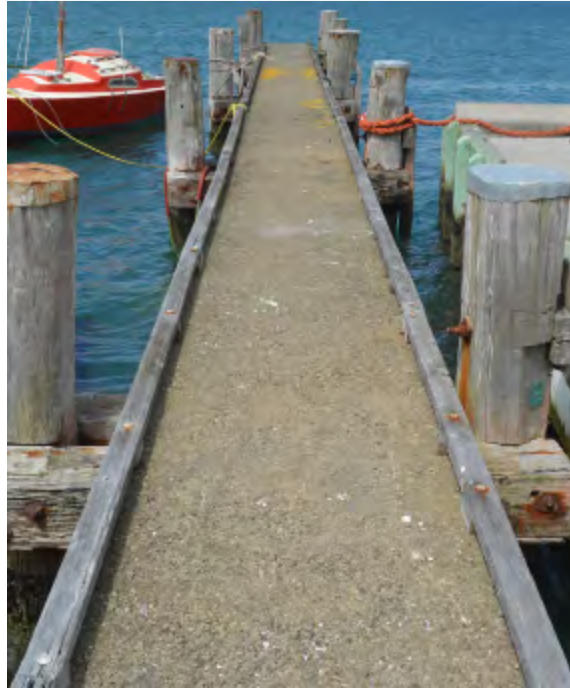
Figure 6-6. Evans Bay Yacht Club South Jetty - Top of Decking

As shown in Figure 6-6 the top of the concrete decking is in a reasonable condition. However the soffit of the decking was found to be subject to spalling of cover concrete, exposure of the bottom reinforcement and reinforcement corrosion also resulting in extensive rust staining of the deck soffit as shown in Figure 6-7.

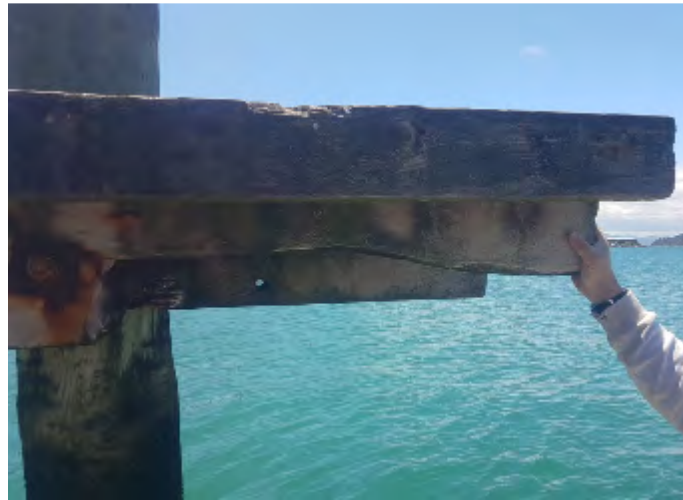
The overlapping joists were found in a reasonable condition, as can be seen in Figure 9-4, with the exception of the last joist, shown in Figure 9-5, where the end of the joist split and the timber below has broken off.

Figure 9-5. Evans Bay Boat Ramp South Jetty – Joist Split With Broken Off Timber Section

It would be recommended that the last seaward joist is replaced.

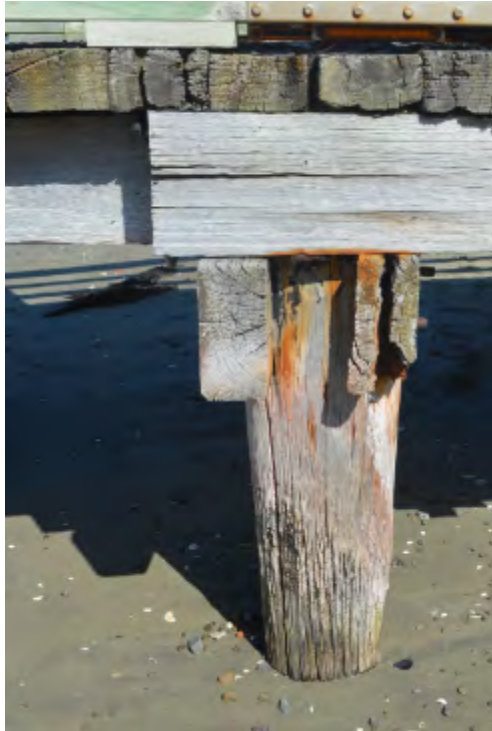
Common defects to most joists and bearers comprised splitting of the beam ends as shown in Figure 10-6.

Figure 10-6. Seatoun Wharf – Splitting of Bearer and Joist Ends

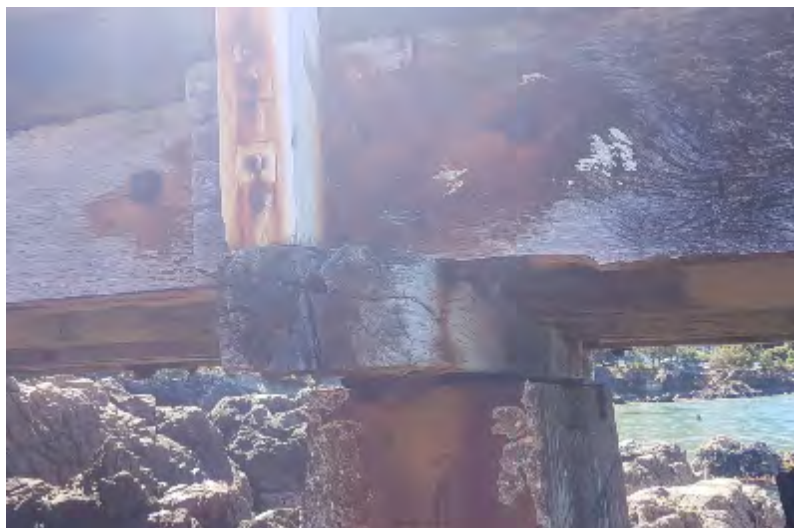
Figure 11-8. Karaka Bay Wharf – Bearer End Splitting and Onset of White Rot

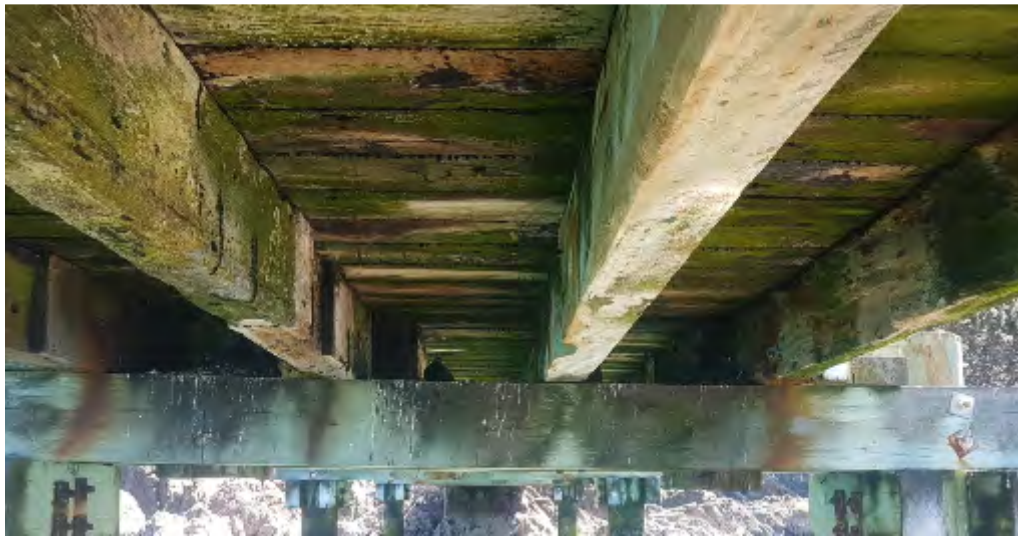
The joists, which have not been sistered yet, are the joists in the end-span of the wharf. Refer to Figure 11-10. These joists also showed significant splitting at the ends. Therefore, it is recommended to sister these joists as well, as part of ongoing wharf maintenance.

Figure 11-10. Karaka Bay Wharf – Joists in End Span

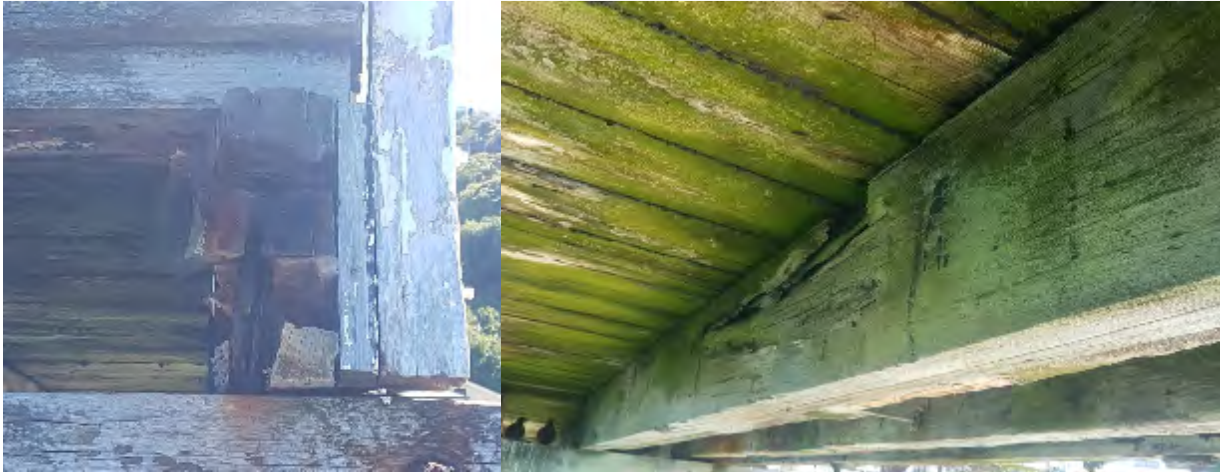
Figure 11-11. Karaka Bay Wharf – Splitting and Cross Section Loss in Existing Joists

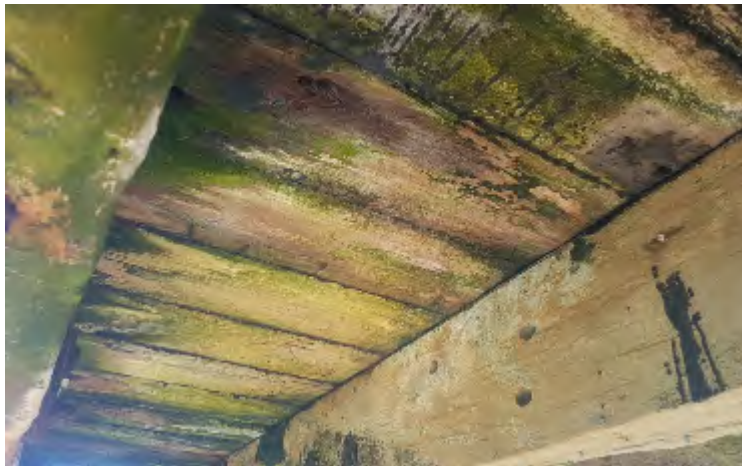
The underside of the decking planks showed extensive mould which is expected given the environmental conditions. Refer Figure 11-12. Otherwise no other defects were encountered.

Figure 11-12. Karaka Bay Wharf – Underside of Decking

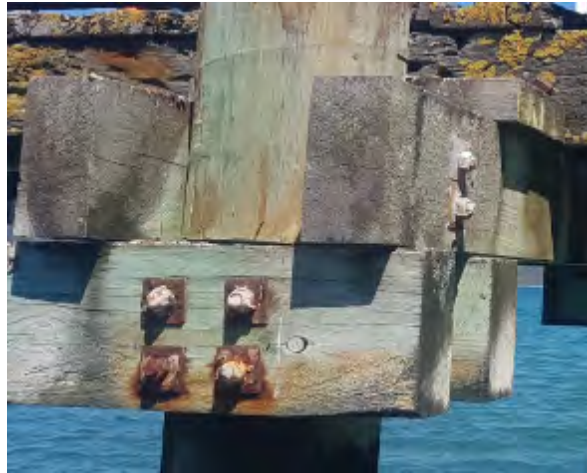
The bolted connections at the replacement underpinning displayed corrosion being not stainless steel, as shown in Figure 11-15. However, the corrosion is not as far advanced as for the other connections comprising fixings of handrail posts to joists and decking planks to joists and should continue to be replaced with stainless connections.

Figure 11-15. Karaka Bay Wharf – Bolted Connection of Underpinned Pier

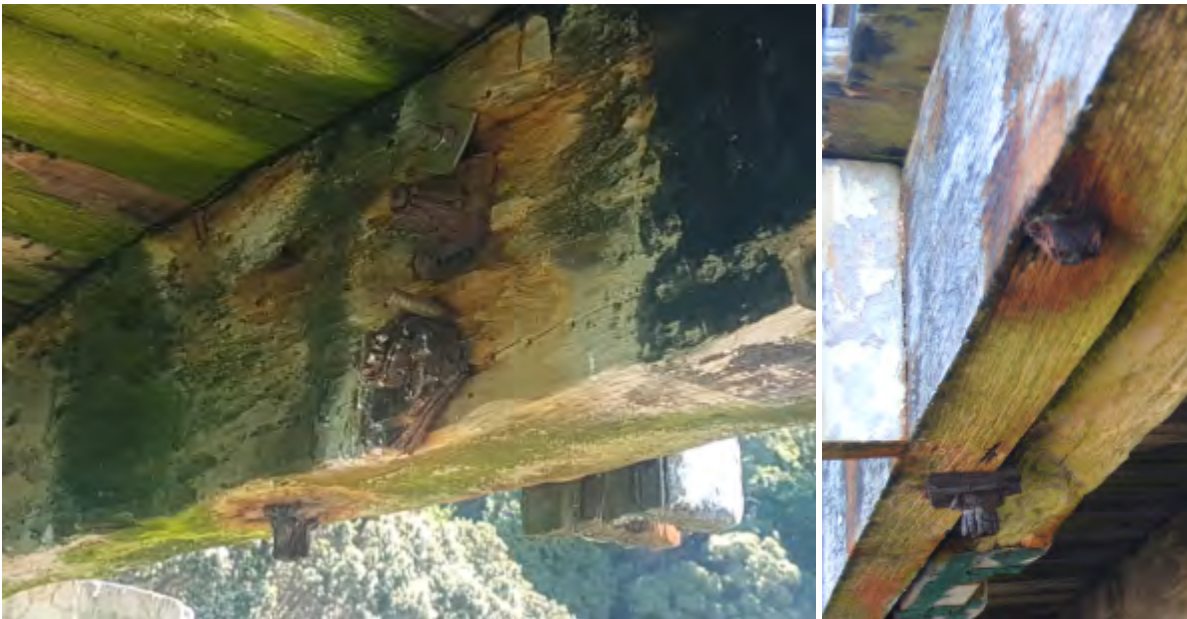
Figure 11-16. Karaka Bay Wharf – Bolted Connections of Original Joists and Decking Planks
