WCC Marine Assets Structural Condition Assessment 2017

Prepared for Wellington City Council

Prepared by Beca Limited

29 March 2018

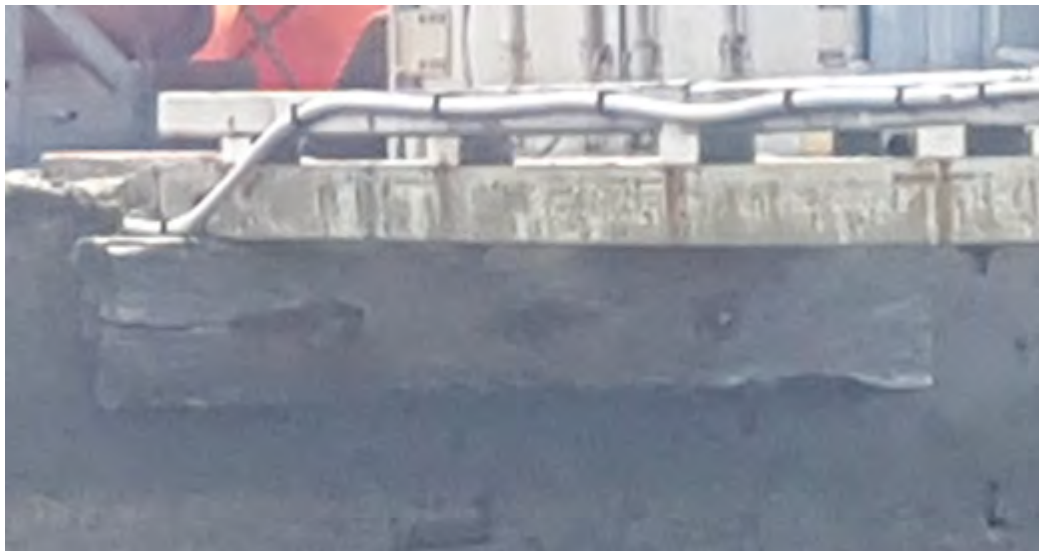
Figure 5-5. Evans Bay Yacht Club Northern Jetty, End Bearer at Abutment

The bearers to the concrete deck were found to be in a reasonable condition, refer to Figure 5-4, with only the bearer mounted at the landward abutment in Figure 5-5 having undergone horizontal splitting from the bearer end face to the fastening.

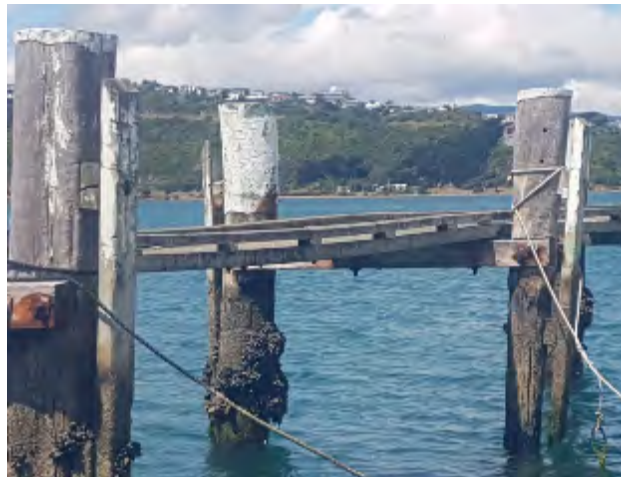
Figure 5-9. Evans Bay Yacht Club Northern Jetty, Fenders

The mooring fenders have experienced rot and some cross sectional losses within the tidal zone; however, this is less critical than the condition of the piles. Therefore, it would be recommended to replace the fenders in conjunction with the replacement of timbers at the end of their service life.

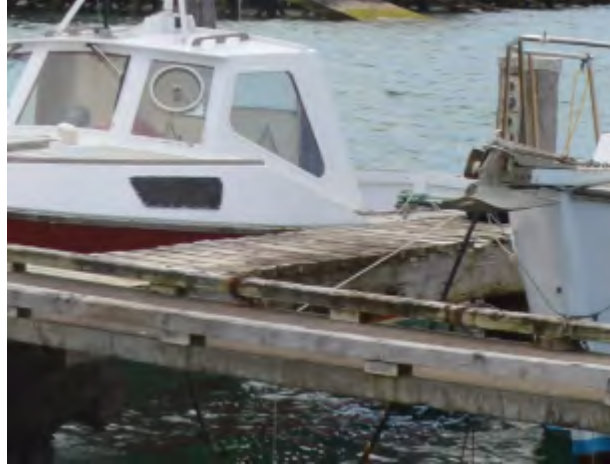
Figure 5-10. Evans Bay Yacht Club Northern Jetty - Finger Jetty

The mooring jetty, shown in Figure 5-10, was prone to a significant amount of swaying which, as confirmed by an underwater visual inspection, was attributed to the mooring pile not being sufficiently embedded to prevent lateral movement.

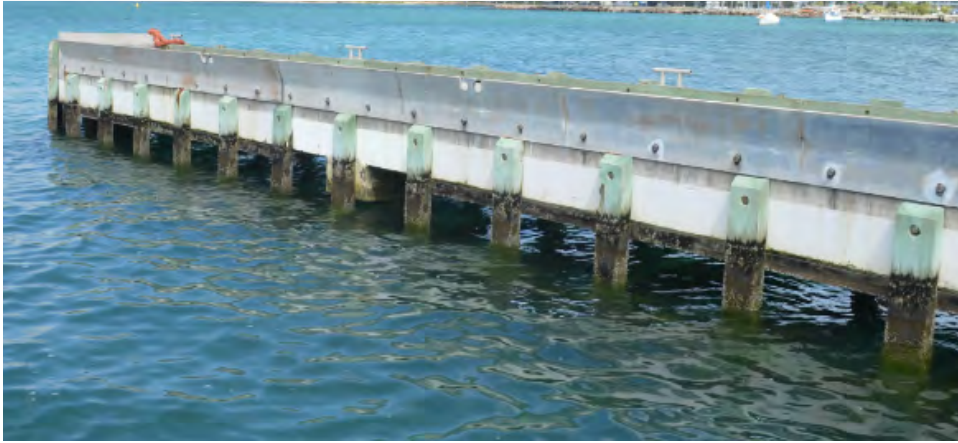
Figure 7-8. Evans Bay Yacht Club Travel Lift – Fenders

Besides typical marine growth the fenders appeared to be in a good condition, with the bolted connections in a good condition and no cross section loss encountered. Refer to Figure 7-8 .

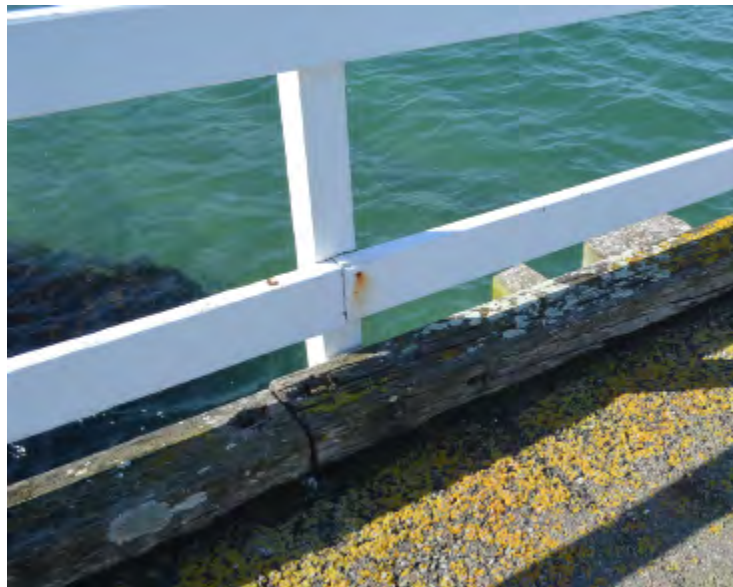
The handrails and toe boards appeared overall to be well maintained, with rust staining observed resulting from ongoing corrosion of the bolted connections. Refer to Figure 11-17. Only localised rot at the toe plank fastening locations appeared to have formed localised pockets, as shown in Figure 11-18. It is recommended that once the depth of these pockets is more than 50% of the toe plank thickness, the affected planks are replaced.

Figure 11-18. Karaka Bay Wharf – Handrail and Kick Board

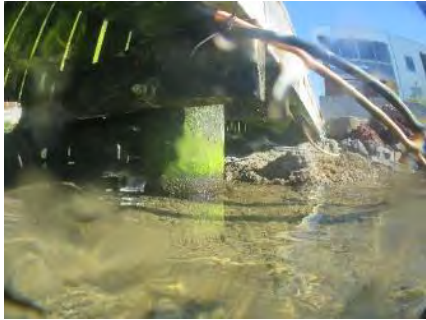
PILE #	RATING	COMMENTS	PHOTOGRAPH
1	1	Pile in near new condition.

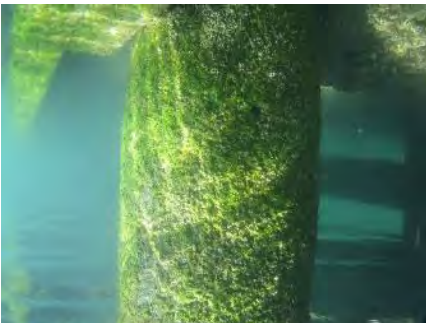
2	1	Pile in near new condition.

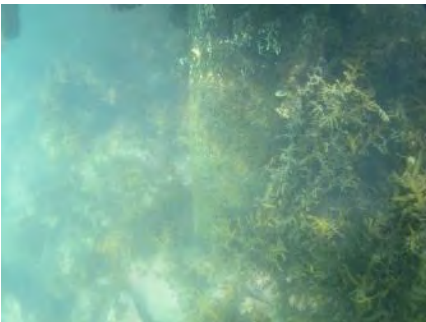
3	1	Pile in near new condition.

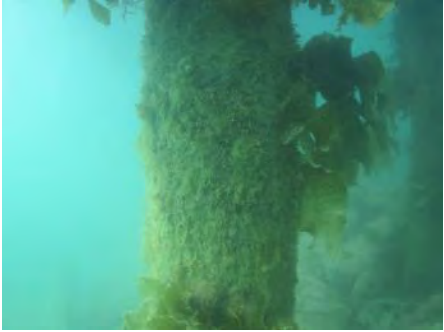
5	1	Pile in near new condition.

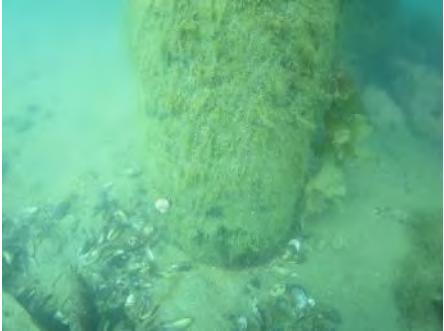
6	1	Pile in near new condition.

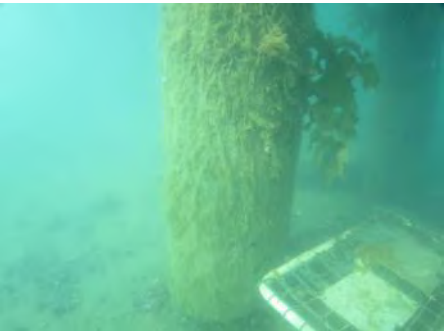
7	1	Pile in near new condition.

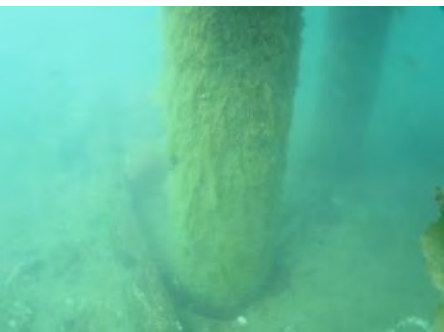
8	1	Pile in near new condition.

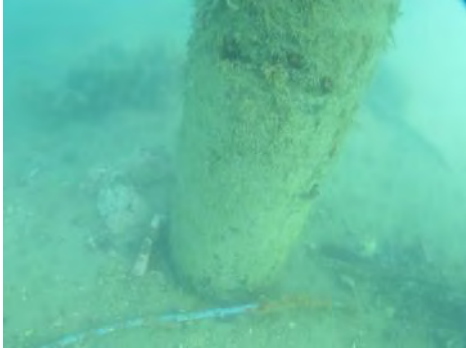
9	1	Pile in near new condition.

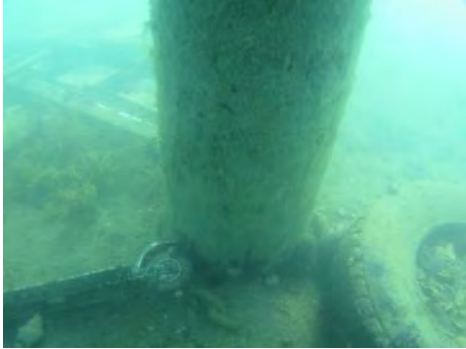
10	1	Pile in near new condition.

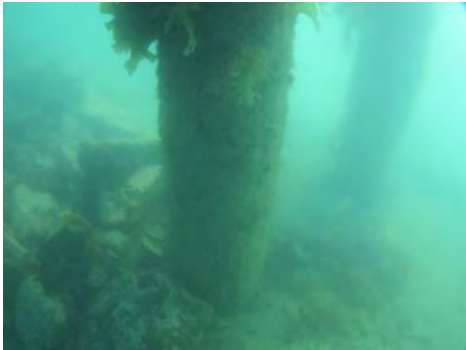
11	1	Pile in near new condition.

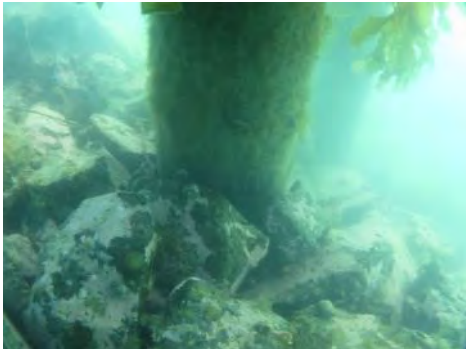
12	1	Pile in near new condition.

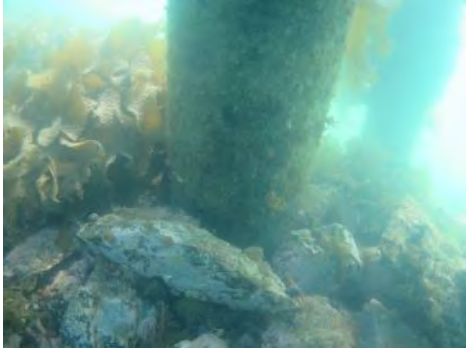
13	1	Pile in near new condition.

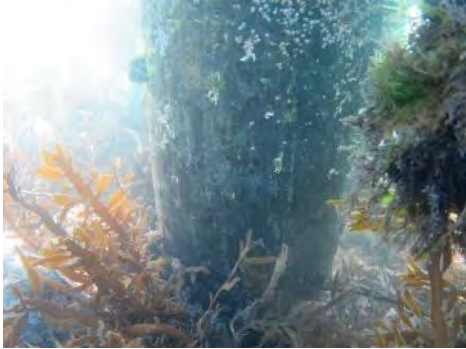
14	1	Pile in near new condition.

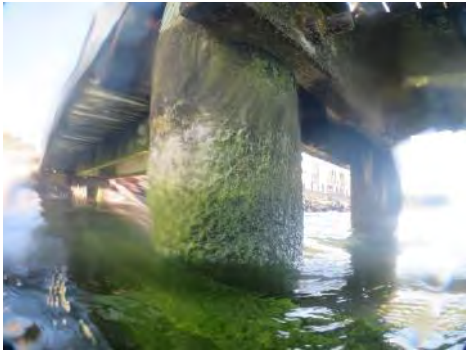
15	1	Pile in near new condition.

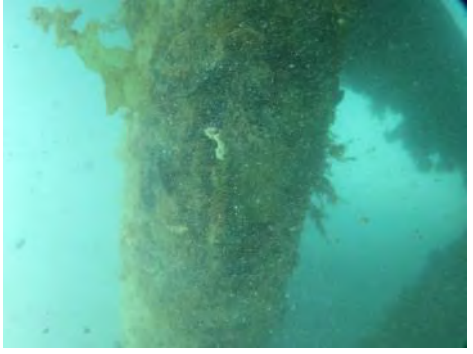
2	1	Top of pile wrapped with copper extending down 300 mm. Pile below copper in good condition.

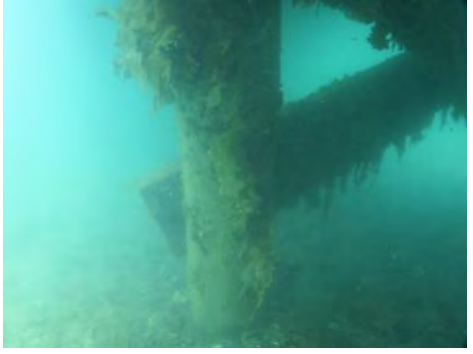
3	1	Top of pile wrapped with copper extending down 300 mm. Pile below copper in good condition.

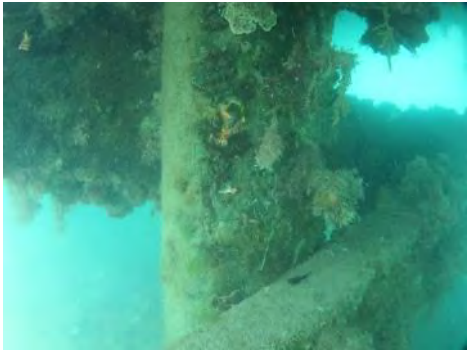
4	1	Top of pile wrapped with copper extending down 300 mm. Pile below copper in good condition.

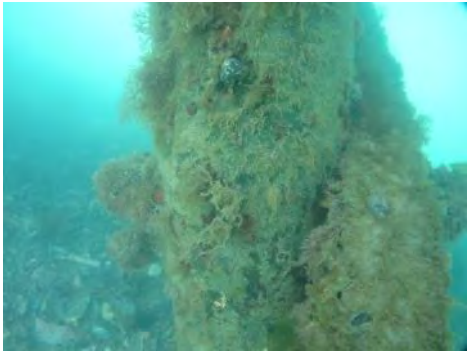
5	1	Top of pile wrapped with copper extending down 300 mm. Pile below copper in good condition.

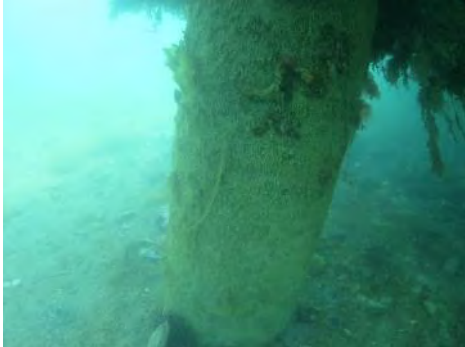
6	1	Top of pile wrapped with copper extending down 300 mm. Pile below copper in good condition.

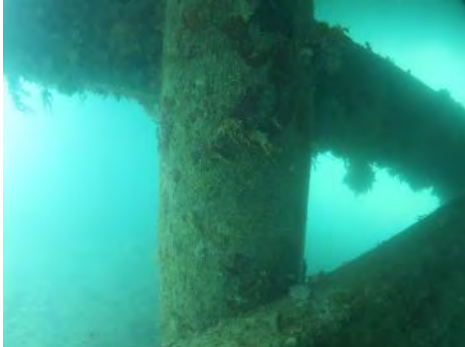
7	1	Top of pile wrapped with copper extending down 300 mm. Pile below copper in good condition.

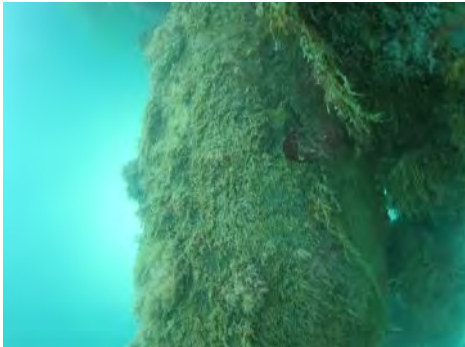
8	1	Top of pile wrapped with copper extending down 300 mm. Pile below copper in good condition.

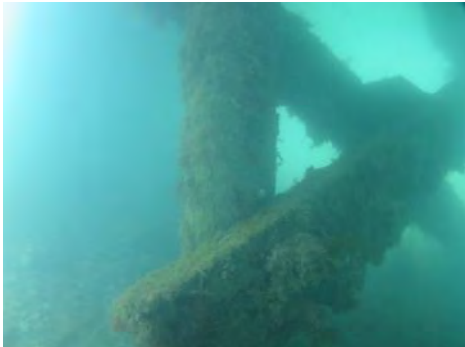
9	1	Top of pile wrapped with copper extending down 300 mm. Pile below copper in good condition.

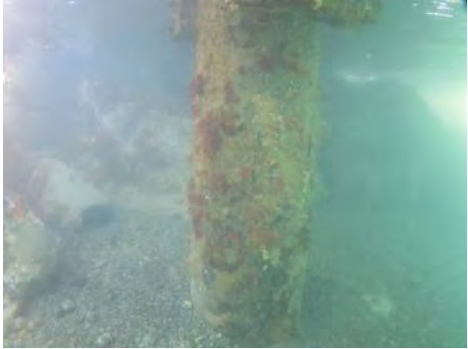
10	1	Top of pile wrapped with copper extending down 300 mm. Pile below copper in good condition.

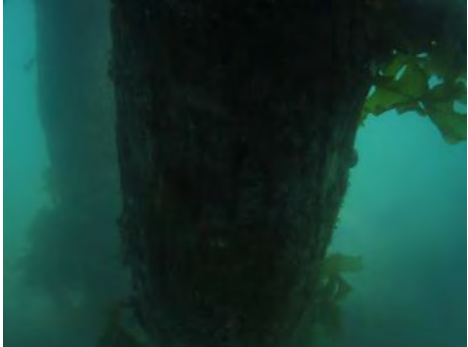
4	2	Vertical splitting around pile.

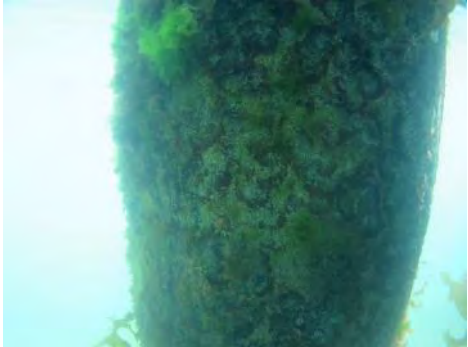
5	1	Timber pile in good condition.

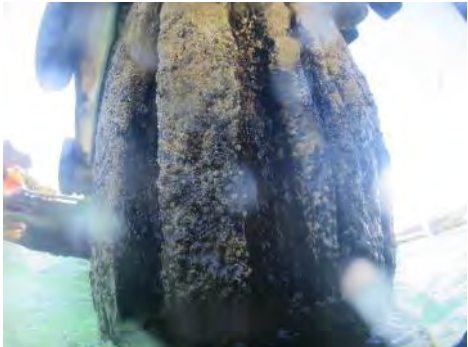
6	4	Deep vertical splitting around pile, approx. 40% loss of cross section.

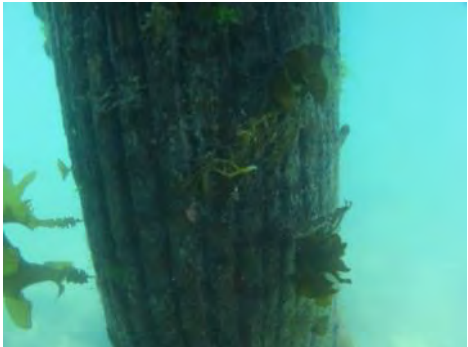
7	3	Vertical splitting 20 – 30 mm deep around pile.

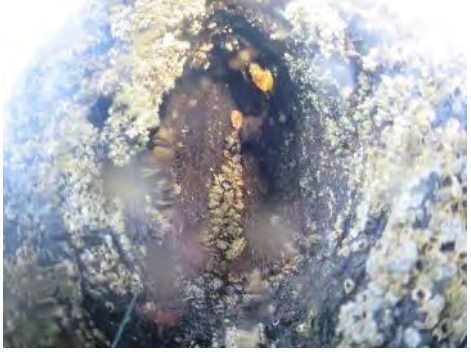
8	4	Cavity in tidal zone. 40-50% reduction in cross section.

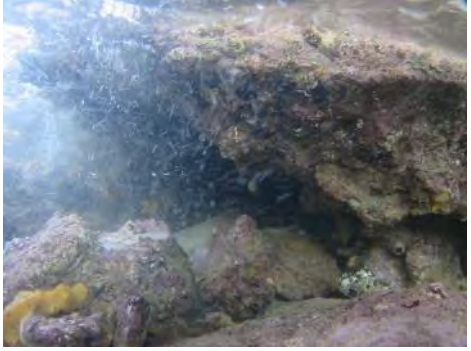
10	6	Pile encased in concrete approx. 1000 mm long, 250 mm thick. Pile does not protrude out bottom of jacket. Concrete jacket is partially floating with 50 % of concrete jacket sitting on rock armouring, but not keyed into rock armouring.

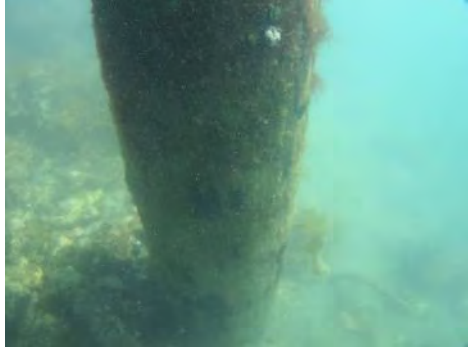
PILE #	RATING	COMMENTS	PHOTOGRAPH
1	1	Timber pile in good condition.

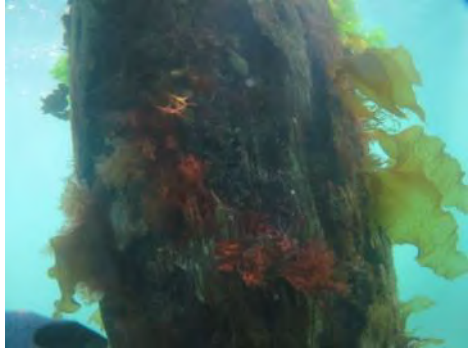
2	3	Average condition, moderate decay.

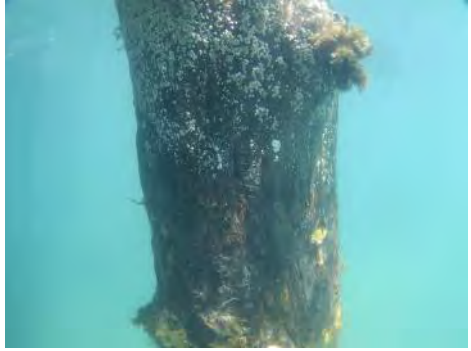
3	2	Timber pile in good condition.

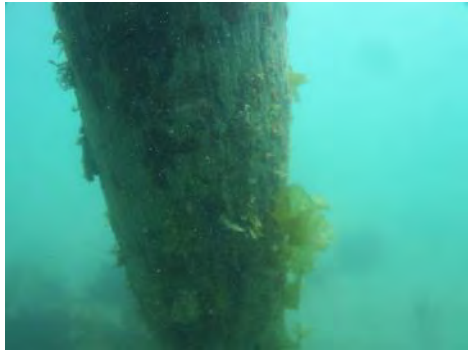
4	1	Timber pile in good condition.

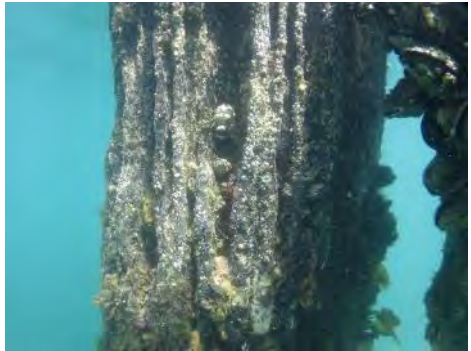
5	3	Vertical splitting in pile.

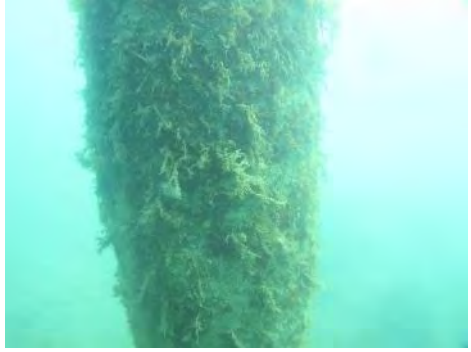
6	1	Copper wrapped, no timber exposed. Solid and appeared in good condition.

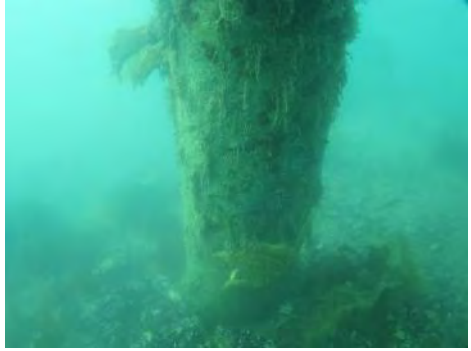
7	1	Copper wrapped, no timber exposed. Solid and appeared in good condition.

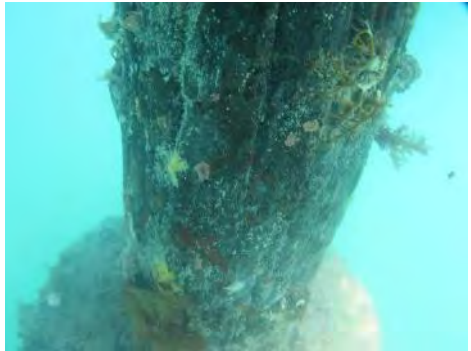
9	3	Concrete jacket around timber pile. 4 metres down from the top of pile to seabed. Concrete in good condition. Pile above jacket rated 3, with vertical splitting.

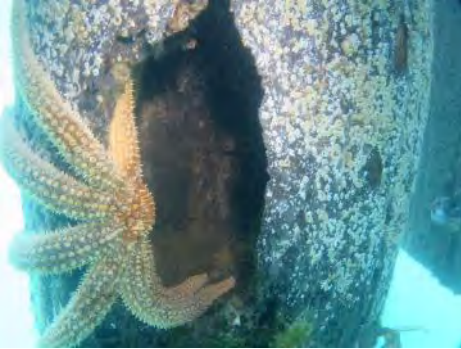
10	5	Pile hollow at waterline. Only thin wall remaining around outside of pile.

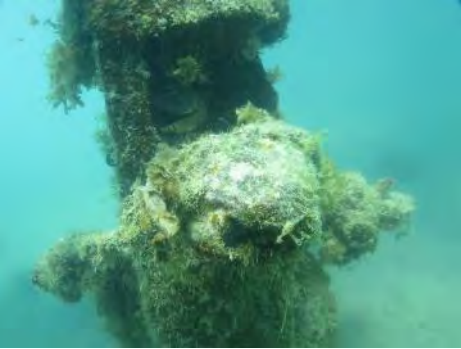
11	5	Pile hollow at seabed. Over 80% of original cross section depleted.

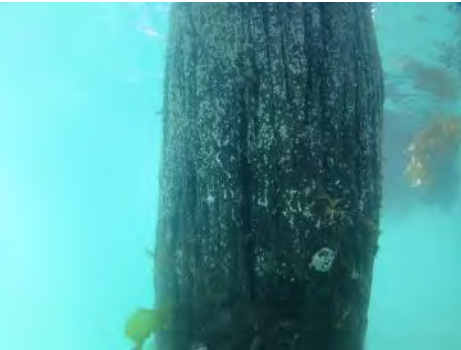
12	3	Timber pile with vertical splitting.

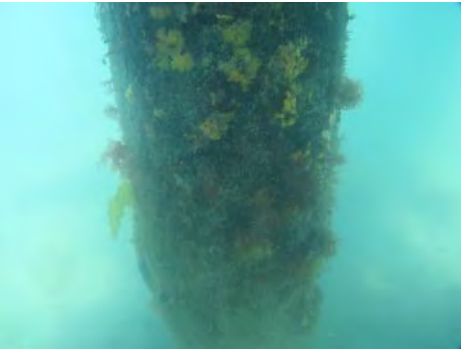
13	2	Timber pile in good condition.

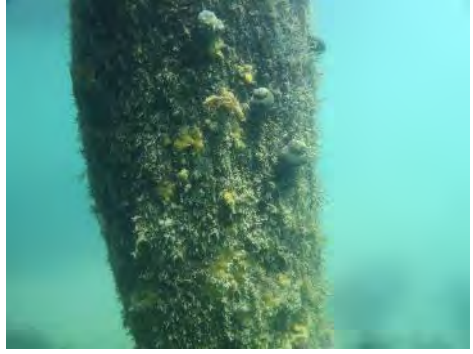
15	2	Timber pile in good condition.

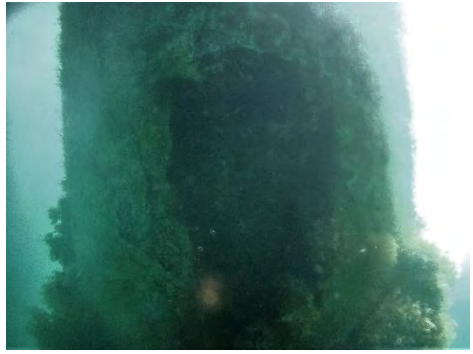
16	3	<p>Note – Free standing mooring rope pile only. This pile was inspected on 14th March, post the main inspection.</p> <p>Timber pile had been copper wrapped. The copper had broken down with approximately 50% remaining. Some rot found on the exposed timber areas. Worst area of rot was 50 mm deep into the pile, 250 mm high and 150 mm wide (shown in photograph).</p>

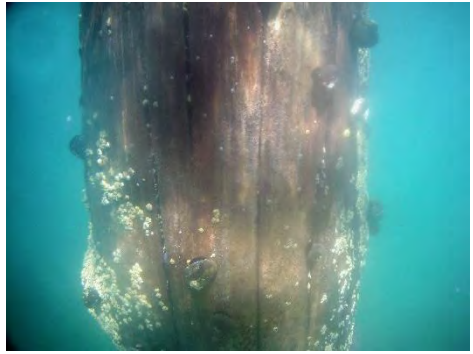
17	3	<p>Note – Free standing mooring rope pile only. This pile was inspected on 14th March, post the main inspection.</p> <p>Timber pile with vertical splitting.</p>

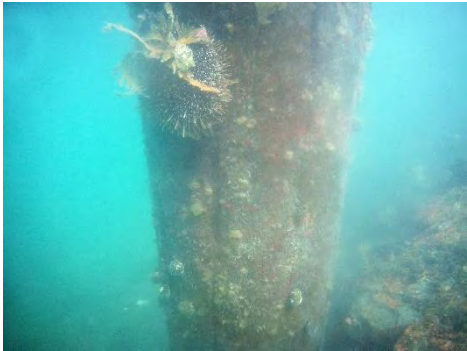
18	3	<p>Note – Free standing mooring rope pile only. This pile was inspected on 14th March, post the main inspection.</p> <p>Timber pile with vertical splitting.</p>

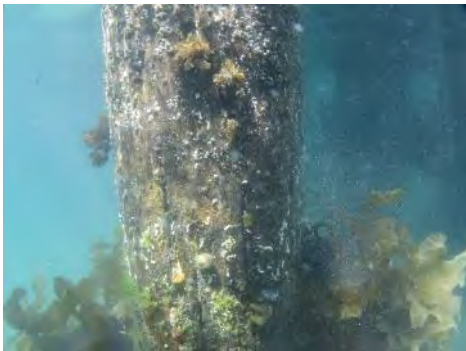
PILE #	RATING	COMMENTS	PHOTOGRAPH
1	2	Timber pile in good condition.

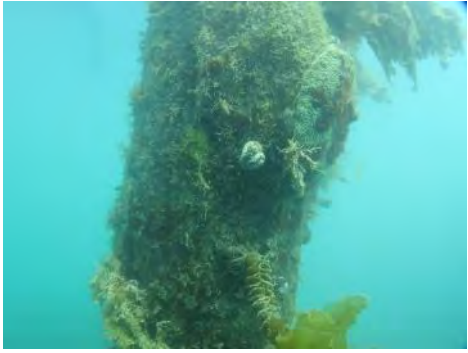
5	2	Timber pile in good condition.

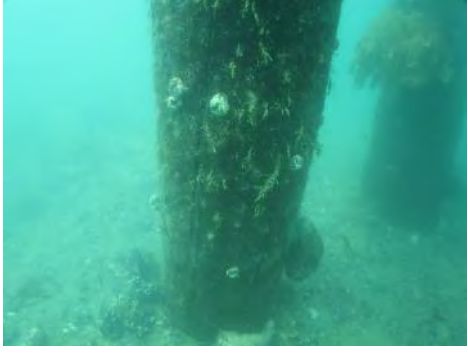
6	2	Timber pile in good condition.

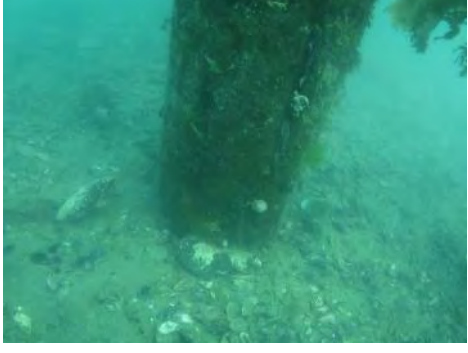
7	2	Timber pile in good condition.

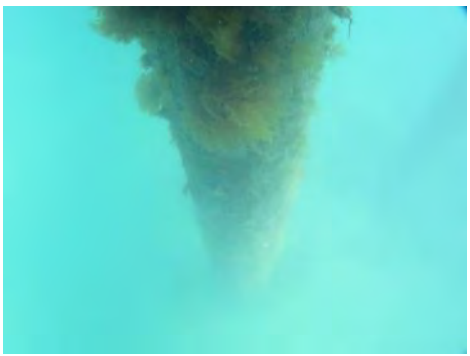
9	2	Timber pile in good condition.

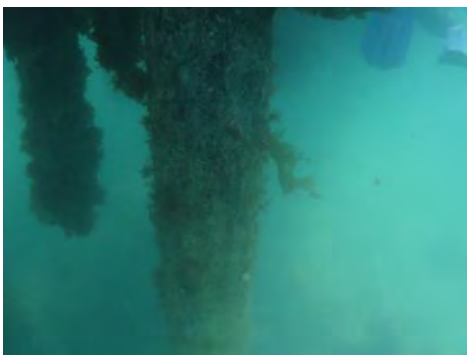
10	2	Timber pile in good condition.

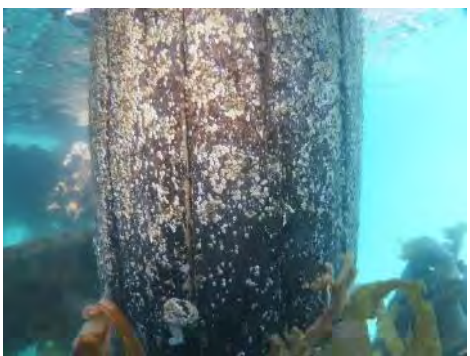
11	2	Timber pile in good condition.

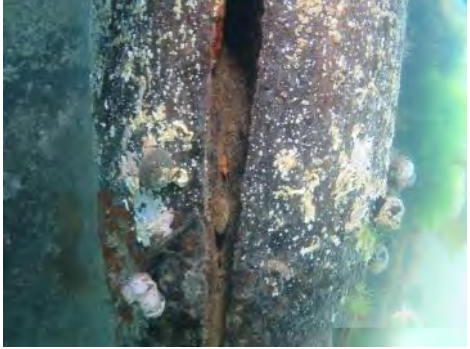
12	3	Crack extending 30% - 40% into pile, approx. 1.5 metres long.

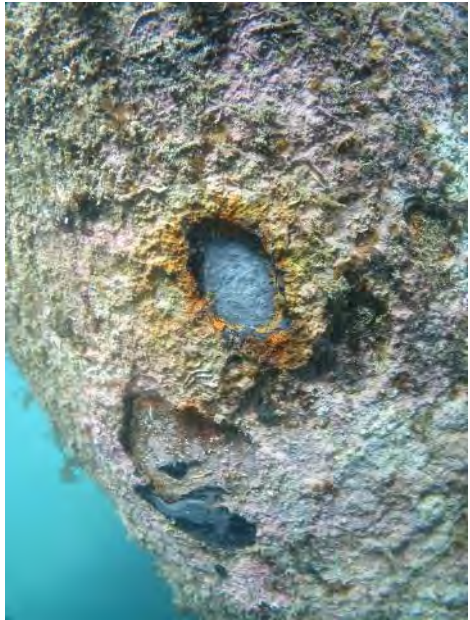
<p data-bbox="1209 1352 1294 1384">REF: 1</p>

PILE #	RATING	COMMENTS	PHOTOGRAPH
1 - 8	6	All piles were steel pile showing signs of corrosion. Pitting in steel up to 5 mm deep.

- Undertake repairs to all piles rated 4 and 5.
- Install anodes on the steel piles on Travel lift piers.

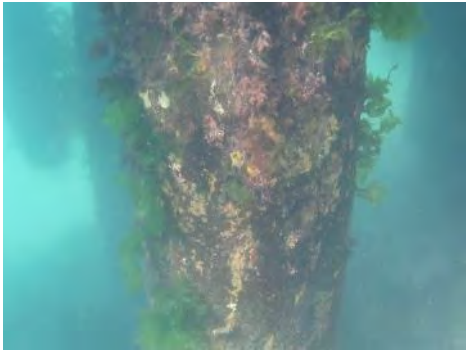
PILE #	RATING	COMMENTS	PHOTOGRAPH
1	1	Timber pile in near new condition.

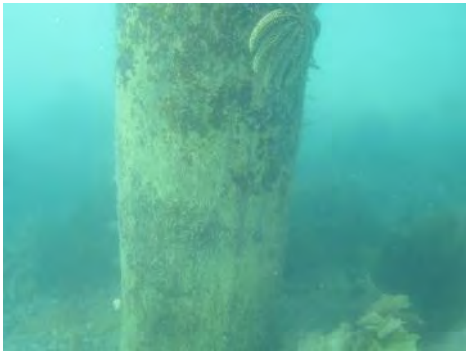
2	1	Timber pile in near new condition.

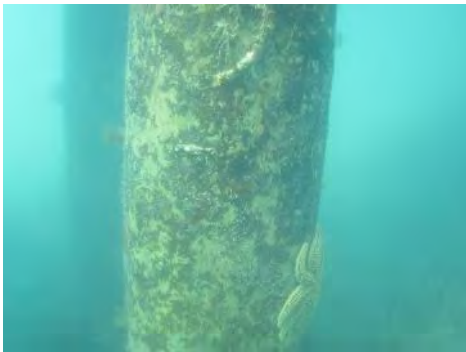
3	1	Timber pile in near new condition.

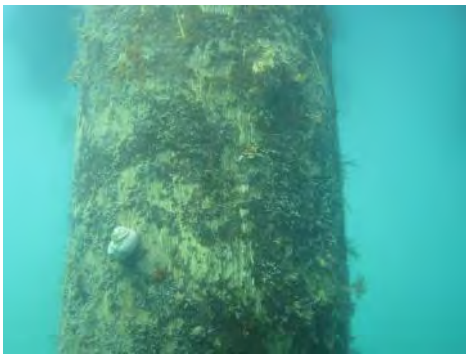
4	1	Timber pile in near new condition.

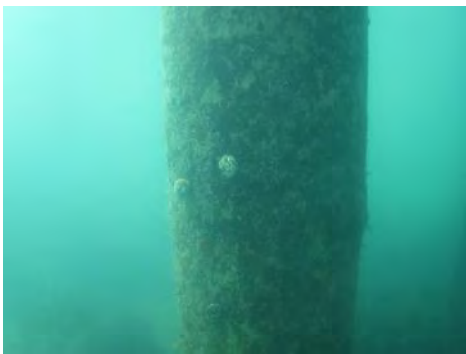
5	1	Timber pile in near new condition.

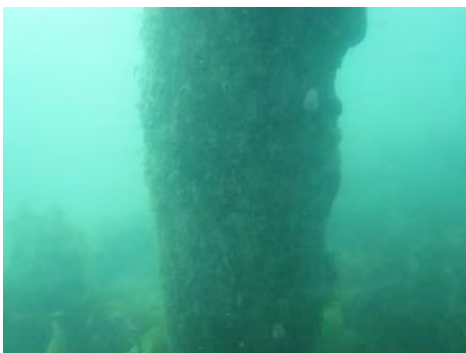
6	1	Timber pile in near new condition.

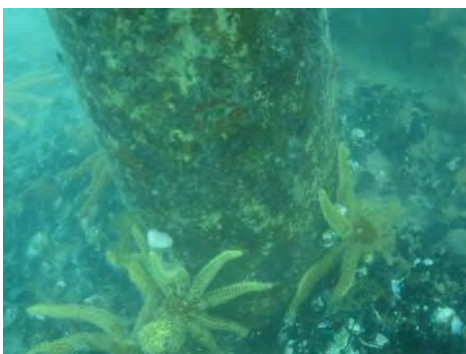
7	1	Timber pile in near new condition.

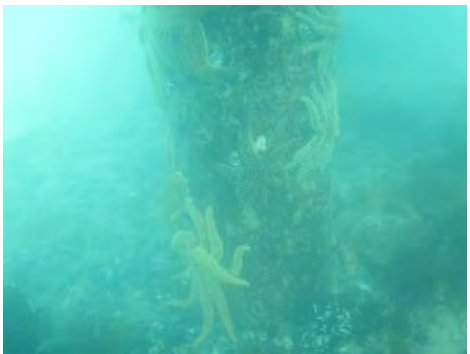
8	1	Timber pile in near new condition.

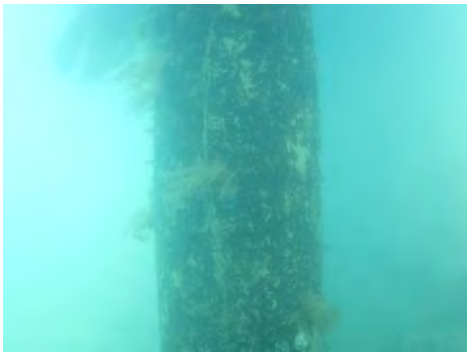
9	1	Timber pile in near new condition.

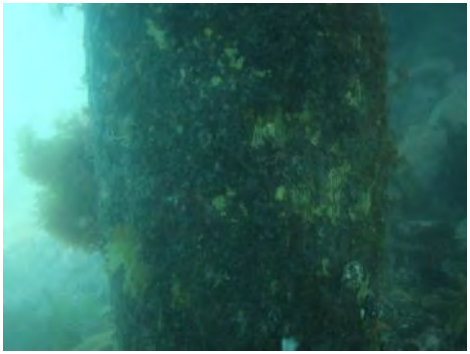
10	1	Timber pile in near new condition.

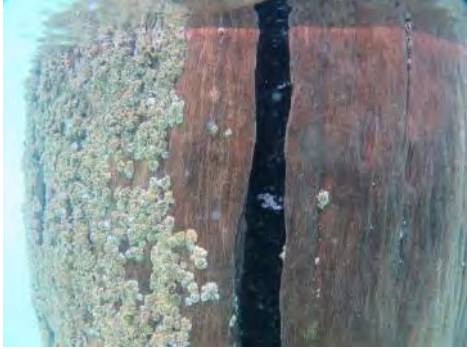
4	3	Vertical splitting in pile, deepest crack found at the waterline and measured 50 mm into pile.

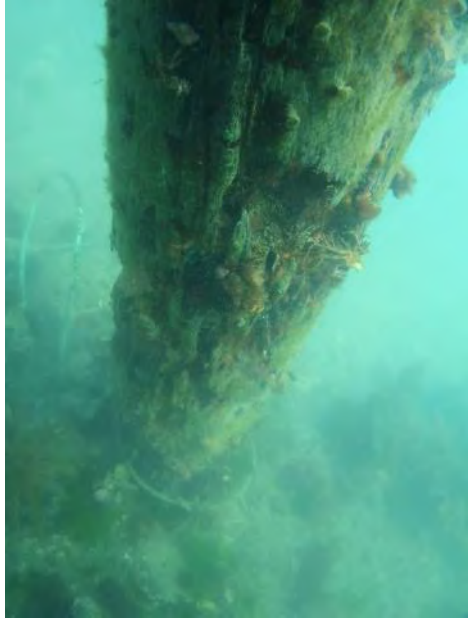
5	3	Timber pile in average condition, moderate decay.

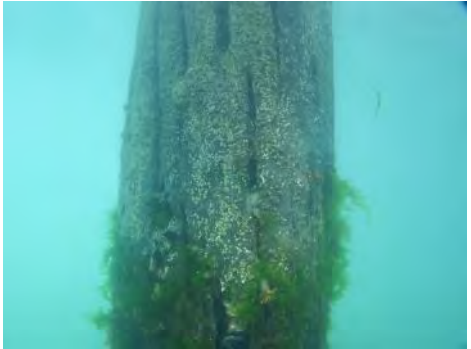
6	2	Timber pile in good condition with minor vertical splitting.

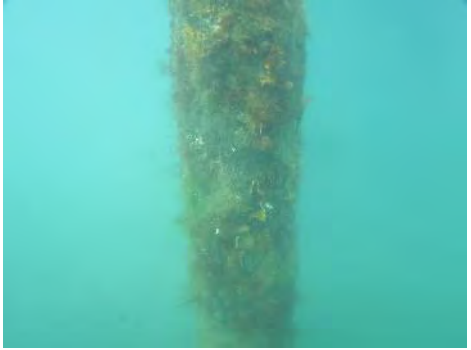
7	1	Timber pile in good condition (smaller diameter pile).

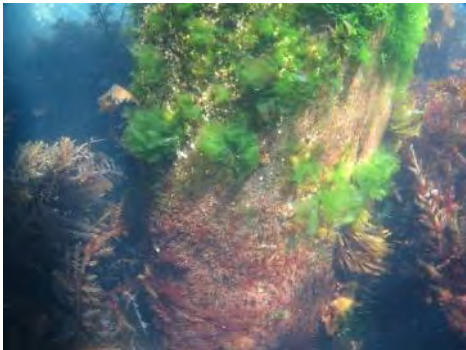
PILE #	RATING	COMMENTS	PHOTOGRAPH
1	N/A	Concrete – above water.	
A2	2	Timber in good condition.

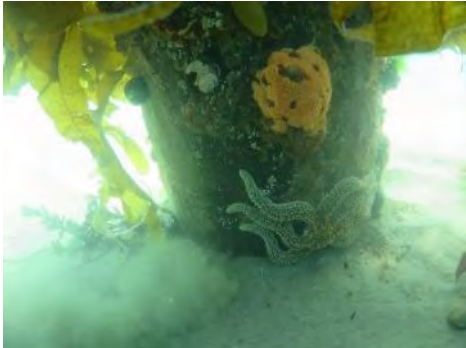
A3	2	Timber in good condition.

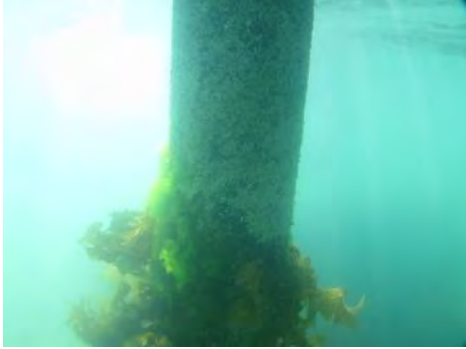
A4	2	Timber in good condition.

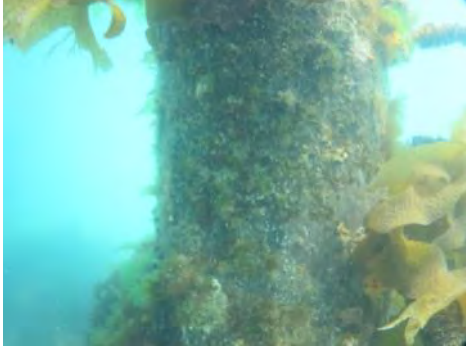
C1	2	Timber in good condition.

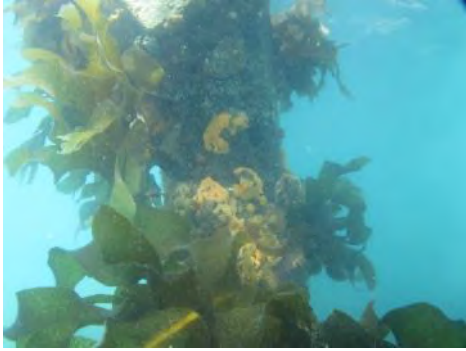
C2	2	Timber in good condition.

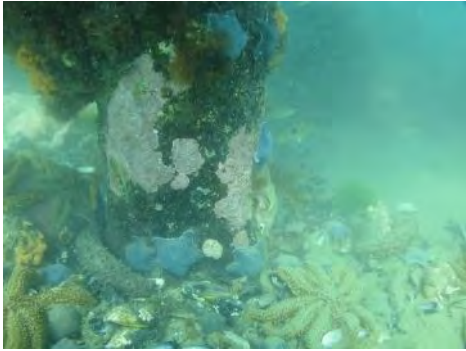
B4	2	Timber in good condition.

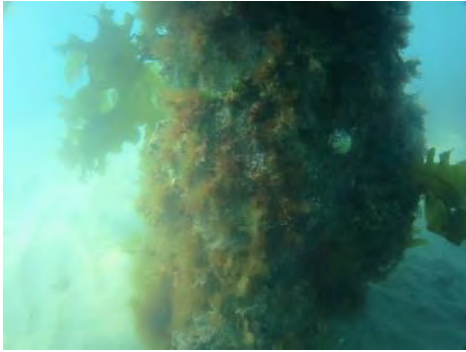
B3	2	Timber in good condition.

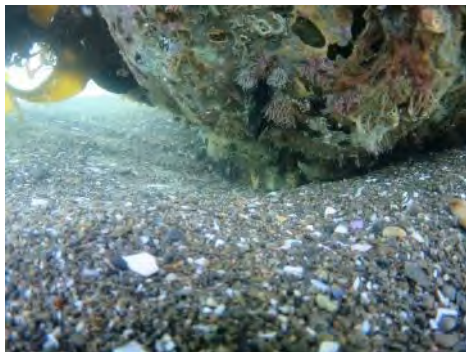
A5	2	Pile encased in concrete approx. 250 mm thick. Concrete has scoured on seaward side, exposing timber pile. Visible pile in good condition.

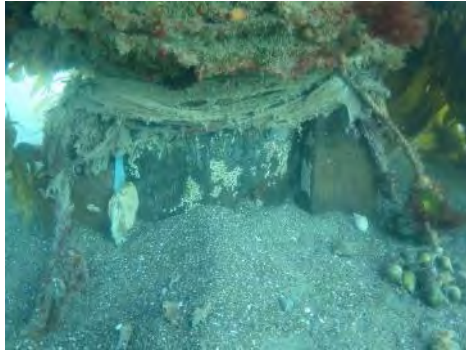
A7	2	Pile encased in concrete 100-300 mm thick. Pile exposed at seabed and in good condition

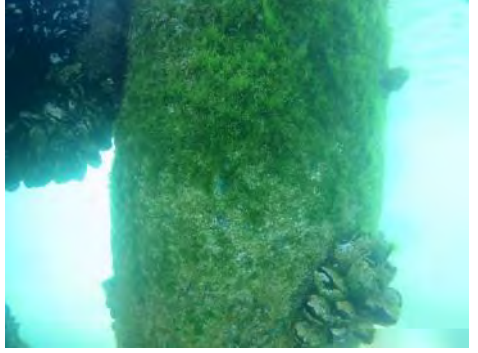
A8a	1	Timber pile in good condition.

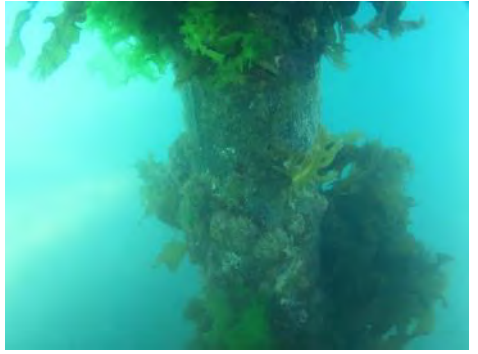
A10	2	Timber pile in good condition.

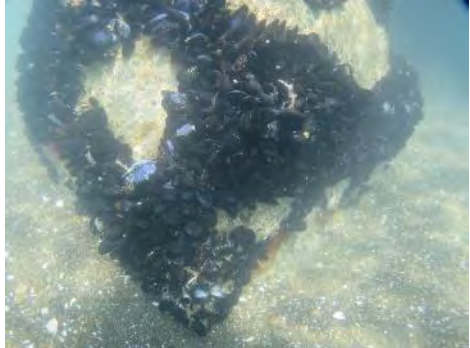
B4	2	Pile encased in concrete approx. 200 mm thick. Concrete scoured on seaward side.

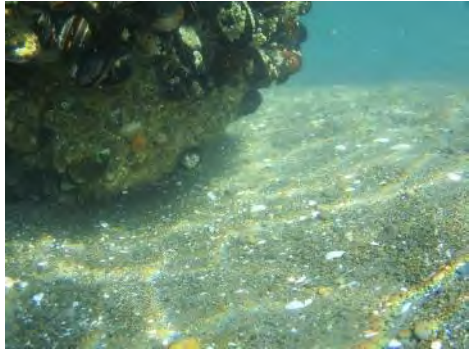
B5	3	Pile encased in concrete approx. 200 mm thick. Concrete scoured on seaward side. Timber pile exposed at seabed.

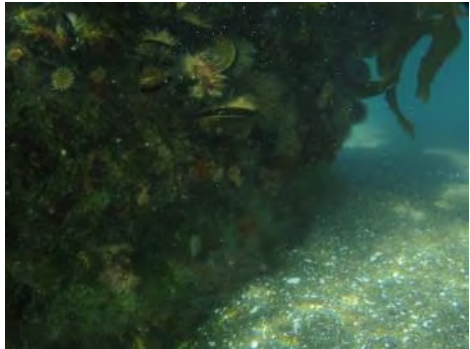
B6	1	Pile encased in concrete approx. 250 mm thick.

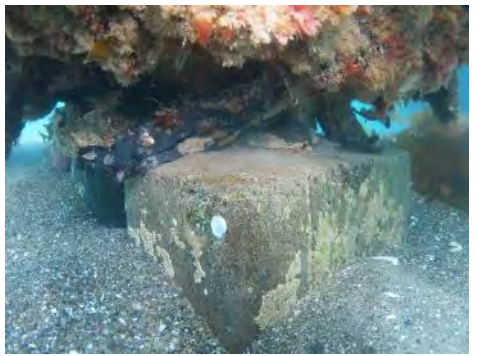
B7	2	Pile encased in concrete. Timber pile exposed under concrete and in good condition. Blocks and straps from repair visible.

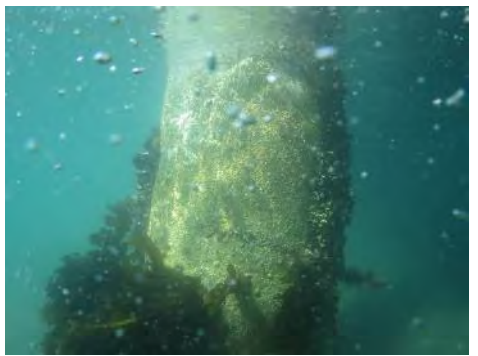
B8	1	Pile encased in concrete. Uneven thickness around pile. Good condition.

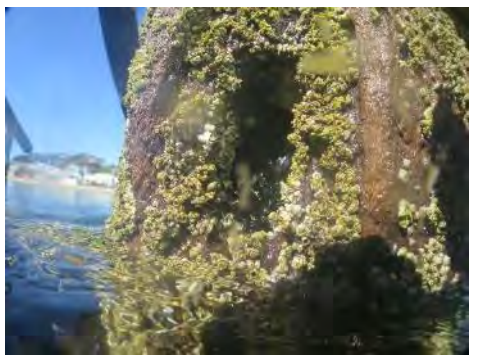
B9	4	Hole at waterline. Remaining pile in good condition

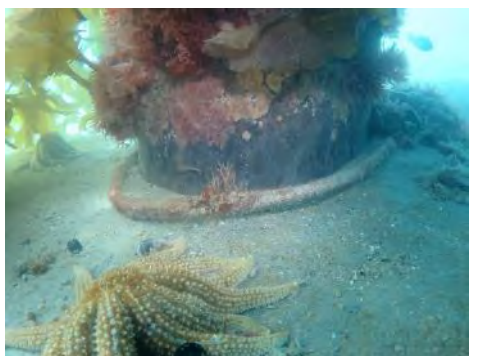
B10	2	Timber pile in good condition underwater. Some splitting above the waterline.

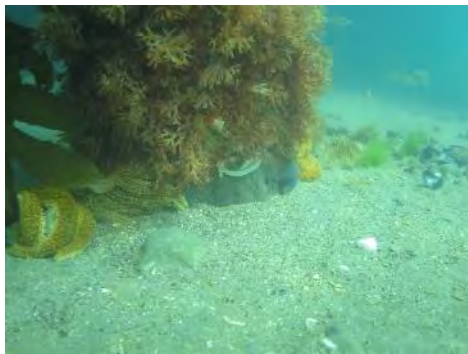
B11	2	Timber pile in good condition.

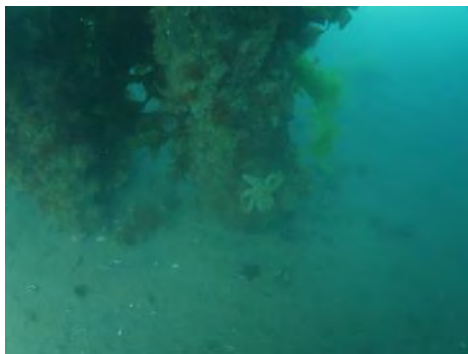
C1	2	Timber pile in good condition.

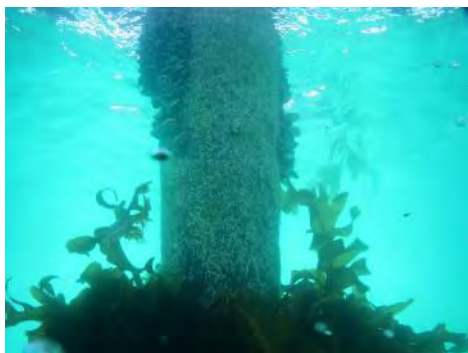
C2	2	Timber pile in good condition.

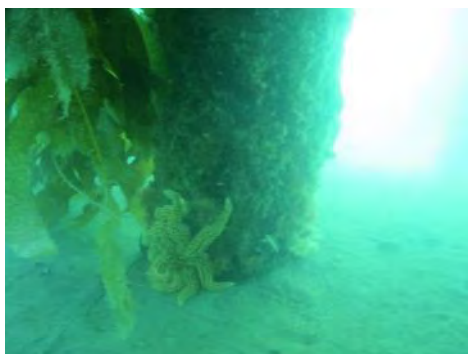
C3	2	Timber pile in good condition.

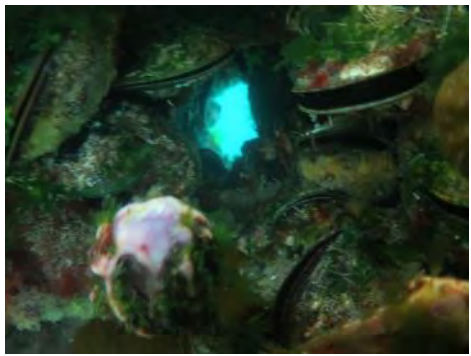
C4	5	Pile hollowed near waterline. Cavity 70 - 80% of original cross section.

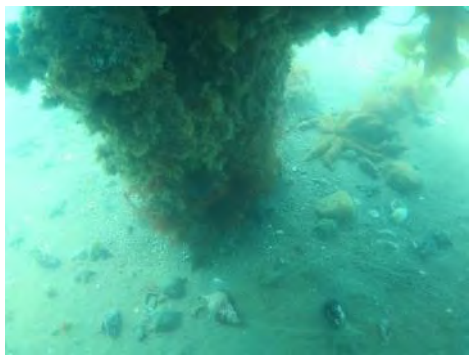
D1	2	Timber pile in good condition.

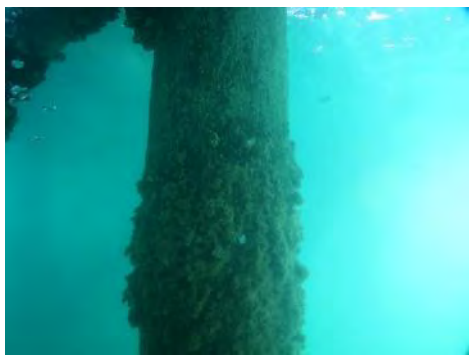
D2		Timber pile in good condition.

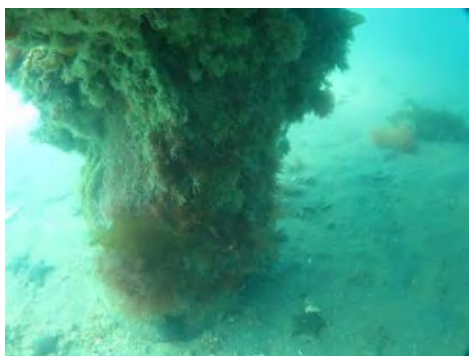
D3	2	Timber pile in good condition.

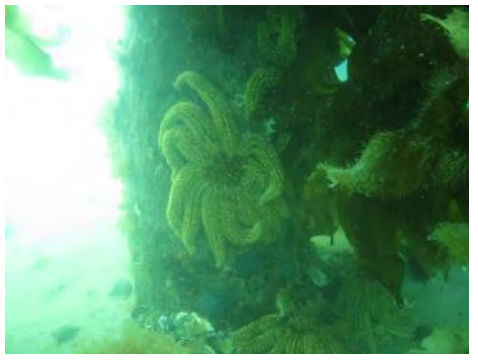
D4	2	Timber pile in good condition.

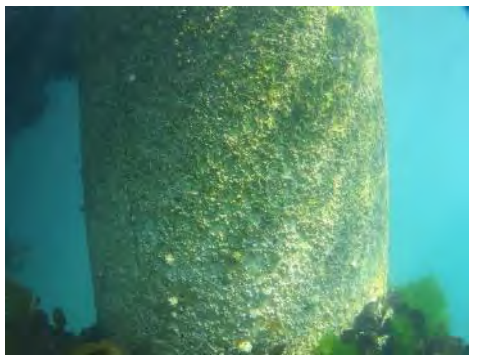
E1	2	Pile encased in concrete to seabed.

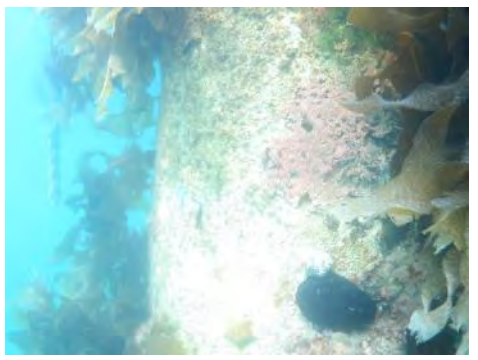
E2	2	Pile encased in concrete to seabed.

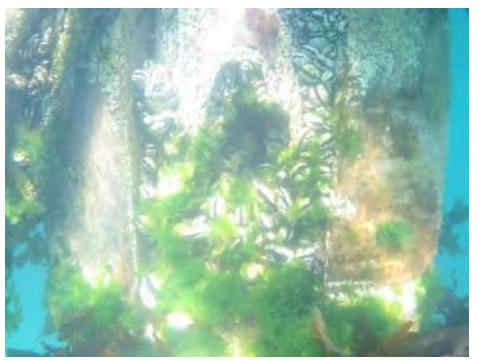
E3	5	Pile encased in concrete to waterline. Above the concrete jacket a cavity was found. 70-80% of original cross section depleted.
